Motoro	bla GmbH, CSS Center Flensburg, Mobile Devices
Title:	Troubleshooting-Guide E398

# E398 DebugGuide

MOTOROLA	Version:	TSG_E398 0.9c 17.06.2005
Title: Troubleshooting-Guide E398	Page:	2 / 12

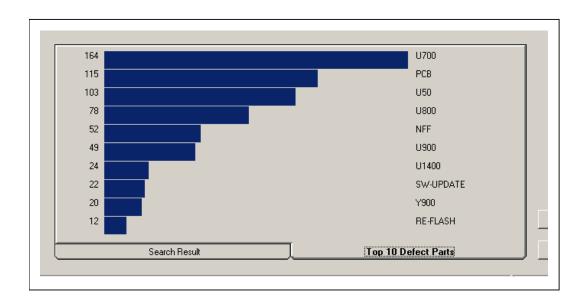
# 3.0 - Top 10 Defective Parts

This is the Analysis of the repaired Phones in NPI-Process, related to the first repair works at all.

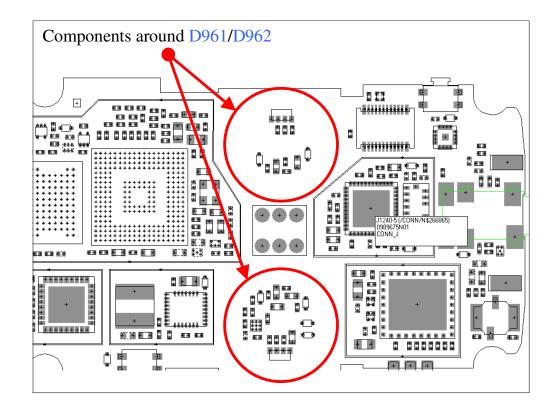
# 5.1 - Alert - Customer Complaint: ALTxx

- 1.) If the Alert is not working
  - check:- Chassis Speaker Assy

- J1261

- the Components around D961
- the Components around D962
- for Dry Joints, Solder Shorts, damaged and skewed Parts
- replace missing or damaged Components
- 2.) If the Alert is still not working

replace: - U900

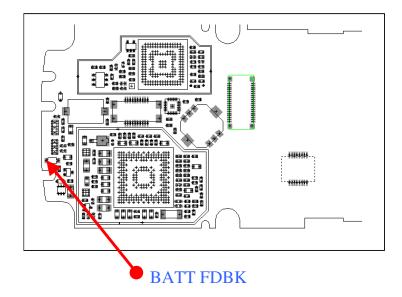
## 5.4 - Charging - Customer Complaint:CHGxx

1.) If charging is not possible check:- J1400

- FL1400

- U900 - J950

- CR900

- for Dry Joints, Solder Shorts, damaged and skewed Parts

2.) If charging is still not possible check "BATT FDBK" at CR900 (if not effective)

- replace missing or damaged Components

> - U900 replace:

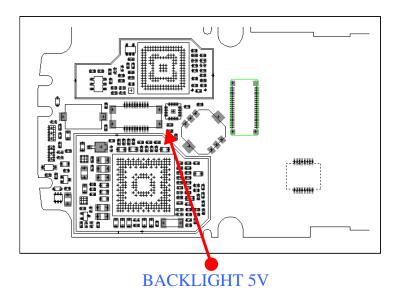
## 5.5 Display Backlight - Customer Complaint: DIMxx

- 1.) If the Display Backlight is not working check:- J1301
- for Dry Joints, Solder Shorts, damaged and skewed Parts
- replace missing or damaged Components
- 2.) If the Display Backlight is still not working check the "BACKLIGHT 5V" at C1454

replace: -

L960 (if not effective)
D960
