Title: Troubleshooting-Guide V3

Doc. No: TSG_V3

V3

Debug - Guide

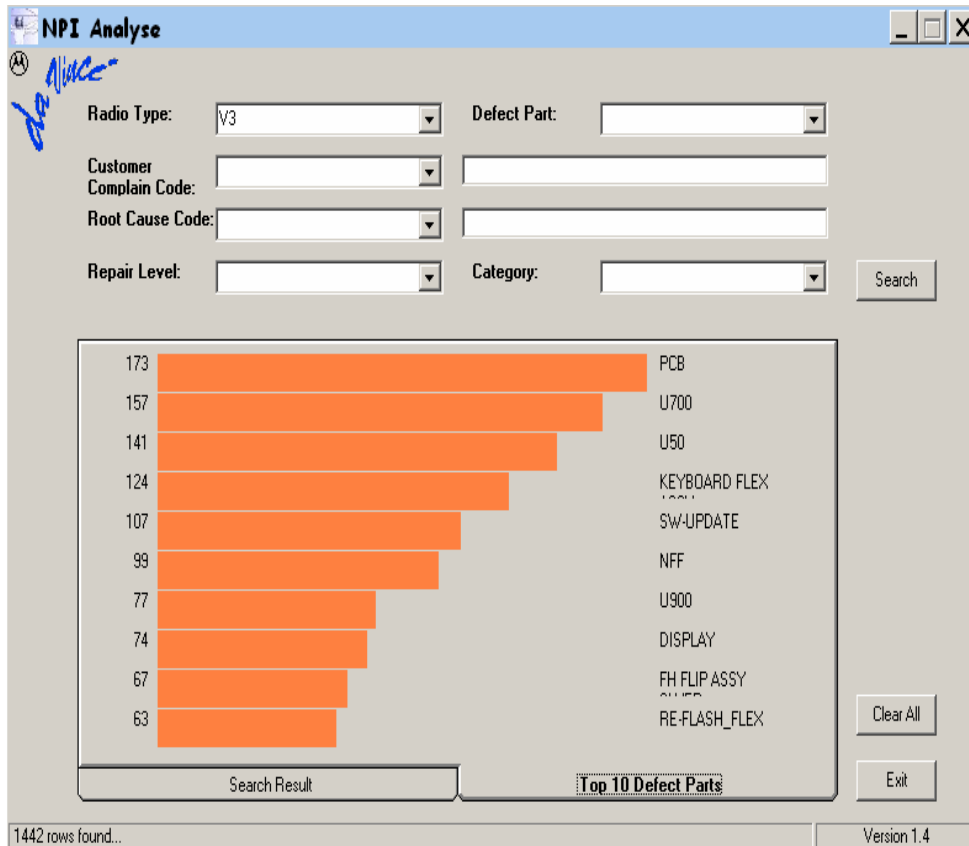
- Fig. 1 shows a analysis-summary of the phones repaired in NPI- process related to the first repair works at all.

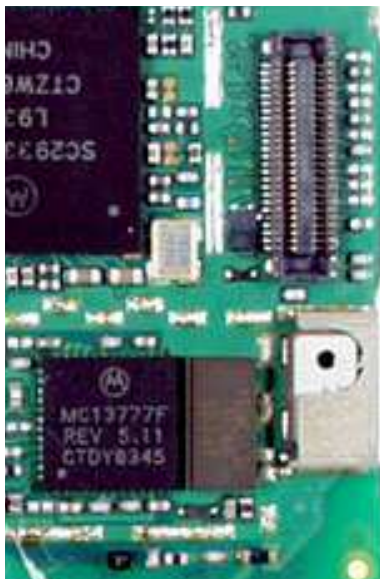
1. If the multi-media ring tones are not working, replace U900.
2. When the charging process is not working, U900 could be defect.
3. Check these voltages, if the phone has a power up problem. Connect PCB with EMU Connector and check the current drain. If the current drain is only ~ 0.6 mA, measure following voltages:

VBoost	~ 5.8V	at C921
VBuck	~ 1.9V	at L920
RF 5V REG	~ 5,0V	at C933

Please refer to Fig. 2

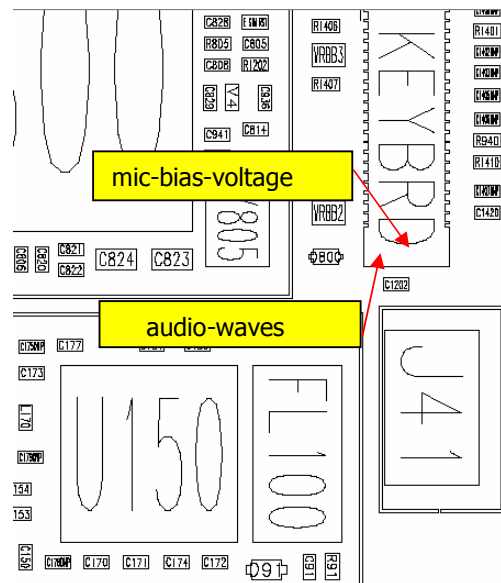
1. If TX-audio is missing, buzzing or is too low set PCB in audio loop mode and check at C1202-2 mic bias voltage ~ 2.15 V from PCAP (Fig. 3). If the bias voltage is present, measure using an oscilloscope measure at C1202-1 int-micp ~1V. While speaking into the microphone check for audio signals on your oscilloscope.
