MOTOROLA

Doc. No: tsg_3g_v3x_level3

Title: Troubleshooting-Guide **V3x Level 3**

Troubleshooting Guide V3x – Level 3

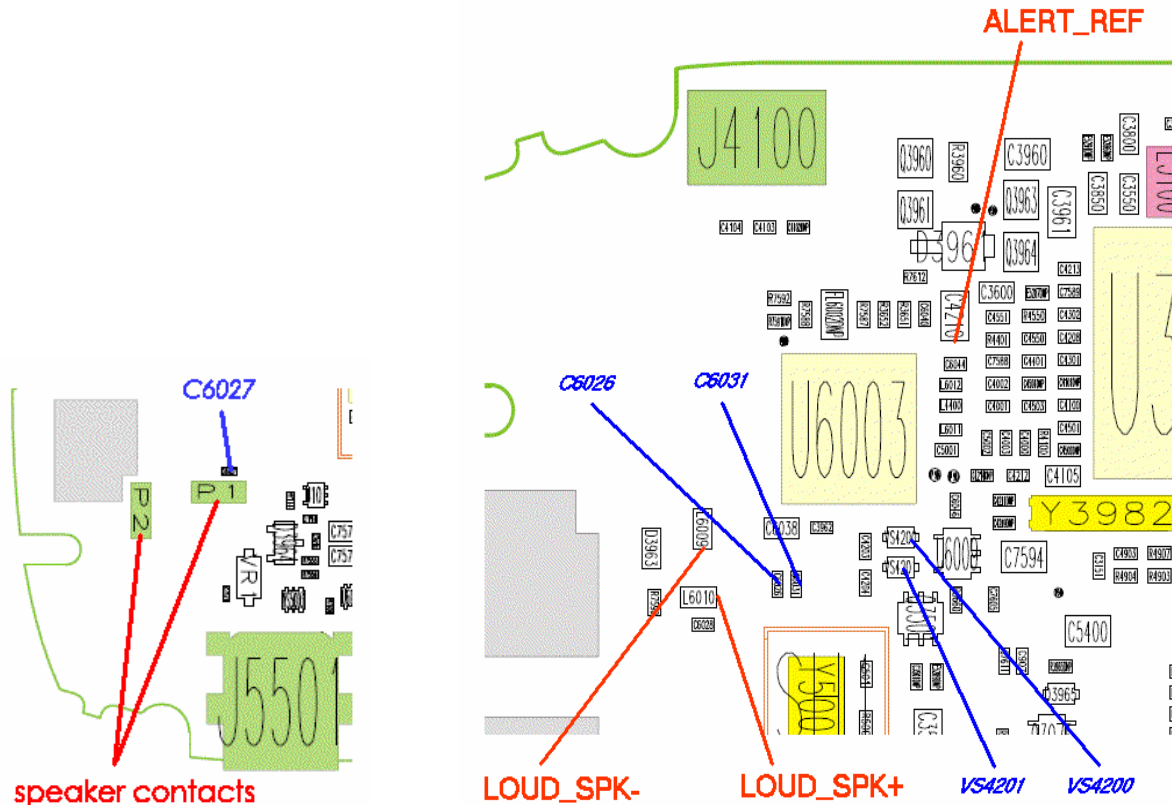
ALT01 Alert – Ring tone, no

ALT02 Alert – Ring tone, low

ALT03 Alert – Ring tone, noise/distortion

Check LOUD_SPK- (P1) and LOUD_SPK + (P2) – both should have around 2.5Vdc

- **if not** check L6009/L6010 for broken connection, VS4200/VS4201/C4203/C4204/C4212/C4213/C6026/C6027/C6028/C6031 for low resistance
- check ALRT_REF 2.5Vdc at C4210
- check PCB for open tracks from P1 to U3000-F1 / P2 to U3000-H1
- you can either use “Repair-Studio” to switch on 1kHz tone to the alert-speaker to check for open tracks, but be careful: **You can have 1kHz and audio in call at P1/P2, but no alert-tone, because the PCAP is defect!**
- **if 1kHz is ok**, replace PCAP2 (U3000)

The alert signal is converted to analog and amplified by the PCAP2, but generated by the POG, so if the PCAP2 alert audio path is ok there could be a problem with the POG not generating the alert signals.

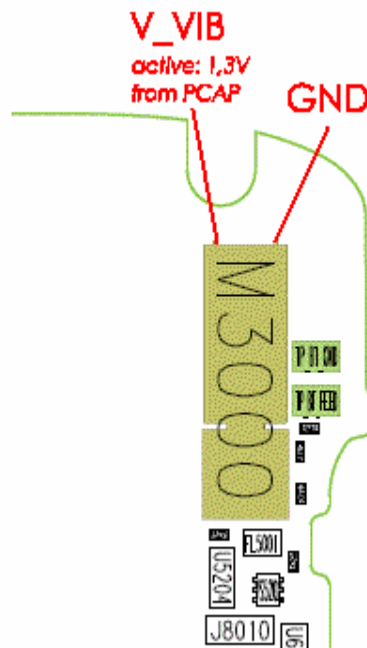
ALT11 Alert – Vibrator, no
ALT12 Alert – Vibrator, weak

Turn on vibrator using Repair Studio/Radiocomm. Measure V_VIB – should be about 1.3 Vdc. V_VIB is provided directly by the PCAP (U3000). To verify if the vibrator is defective a simple method is to provide a supply voltage (1Vdc should be enough) via test probes directly on the vibrator M3000 (radio in off state!). It should be rotating, if not replace the vibrator M3000. Otherwise replace PCAP (U3000).

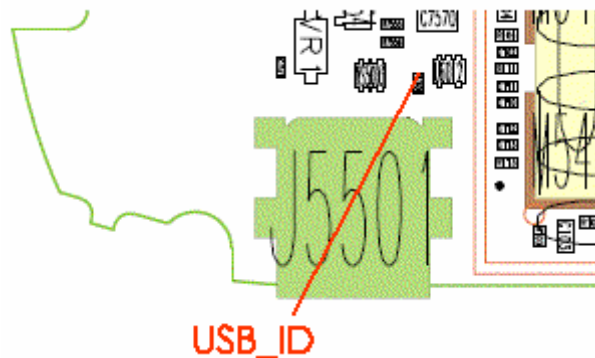
**AUDxx Audio –
Headset Detection problem**

If the headset detection is not working correctly, there is most likely a problem with the detection of any accessory connected to the EMU connector (J5501).

With an open J5501 the voltage at pin 4 of J5501 (**USB_ID**) should be 2,775V when phone is powered on with battery.

For headset detection **USB_ID** line is used. With headset connected voltage on that line should be 1,7V.

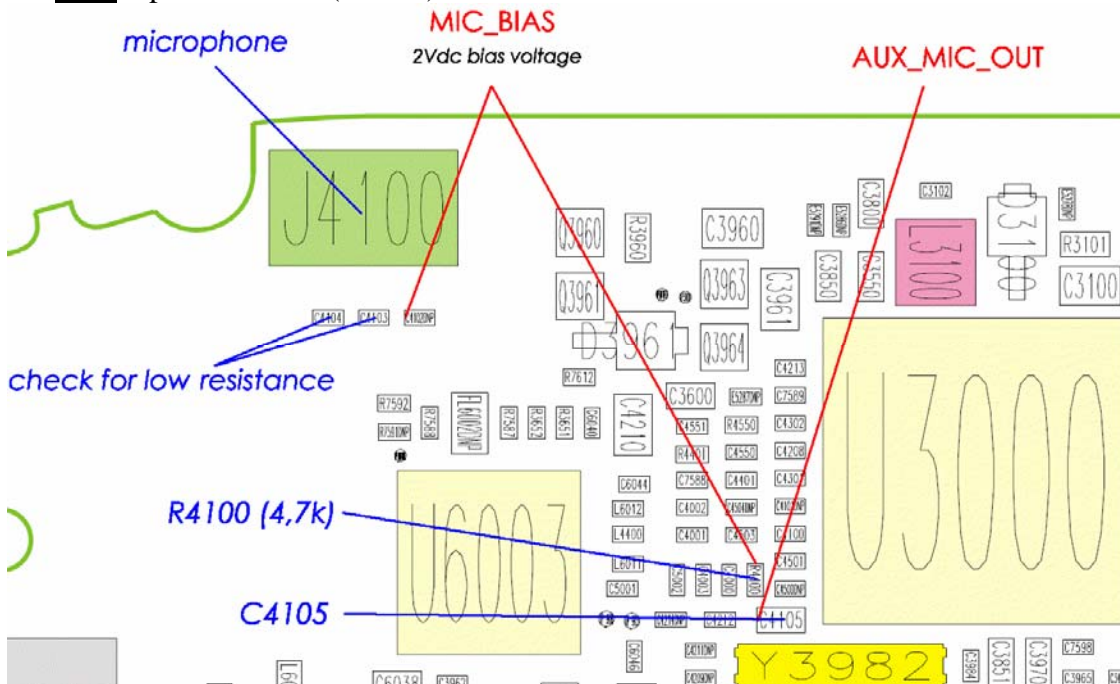
AUD07 Audio – Mic, No

AUD08 Audio – Mic, Low

Set radio in audio loop using Repair Studio/Radiocomm

- check Mic BIAS at R4100-2 – should be around 2Vdc
- **if not** check C4100 for low resistance
- check R4100 (4,7kOhm)
- **if ok** check AUX_MIC_OUT at C4105 while blowing into the microphone to see the audio signal caused by the blowing
- **if not** replace microphone
- **if ok** replace PCAP2 (U3000)

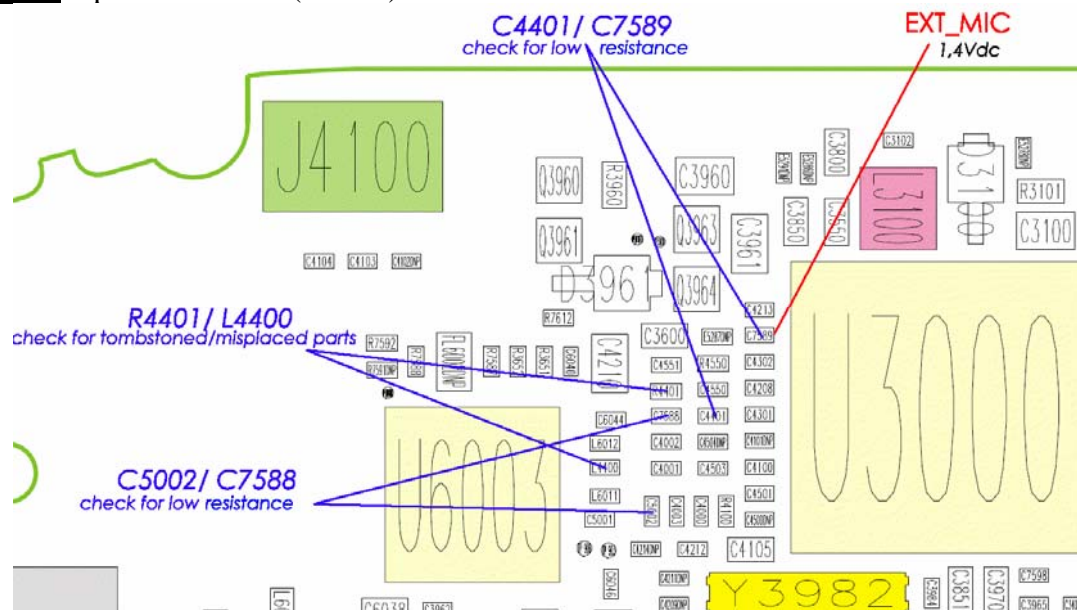
AUD11 Audio – Mic, Headset

Set radio in headset audio loop using Repair Studio/Radiocomm

- check headset Mic Bias at C7589 (EXT_MIC) – should be around 1.4Vdc
- **if not** check C4401/ C7589 for low resistance
- if C4401/ C7589 are ok, replace PCAP (U3000)
- **if headset Mic BIAS ok:**
- check C7588/ C5002 for low resistance and check R4401 /L4400
- **if ok** replace EMU-IC (U6003)

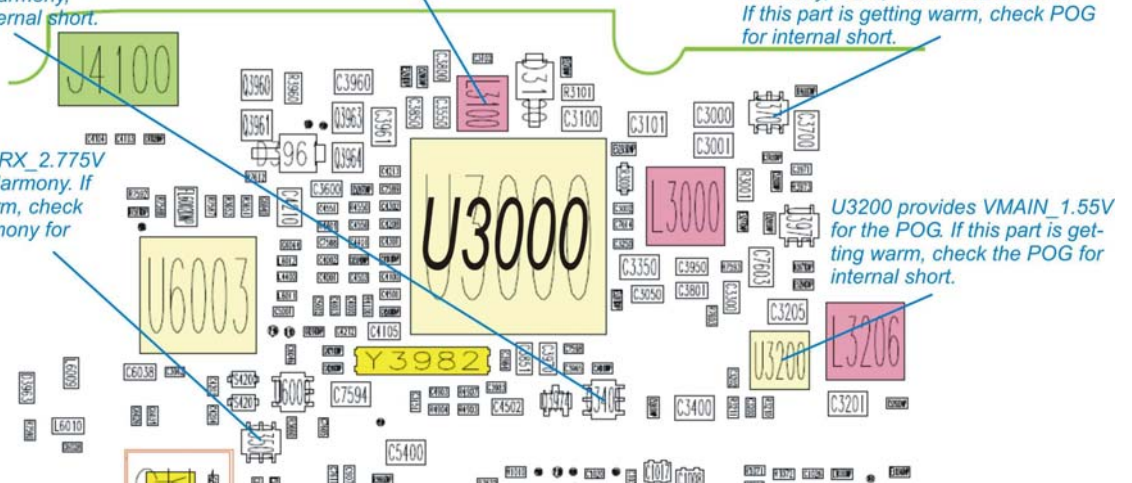
In probably most cases these problems are caused by an off current. First verify whether there is an off current. If there is an off current, it should be checked whether the device draws current via battery and/or via external connector.

In case of an off current via battery there should be a low resistance (less than ~200 Ohm)/ or a short from BATT_P (M5400-1) to GND.

Q3401 provides VRF_TX_2.775V for Blue-Module, Harmony, Rattler and PAs. If this part is getting warm, check Blue-Module, Harmony, Rattler and PAs for internal short.

L3100 is the load-coil for the VBOOST_5.5V. If it is getting hot, there may be a short on the voltage line or L3100 is defect (low inductance).

Q7303 provides VAUX1_2.775V which is used for the display/flip and after passing R7615 as 2.7V supply for POG, Harmony, DOC, PCAP and EMU-IC. If this part is getting warm, check POG for internal short.

Q3501 provides VRF_RX_2.775V for Blue-Module and Harmony. If this part is getting warm, check Blue-Module and Harmony for internal short.

U3200 provides VMAIN_1.55V for the POG. If this part is getting warm, check the POG for internal short.

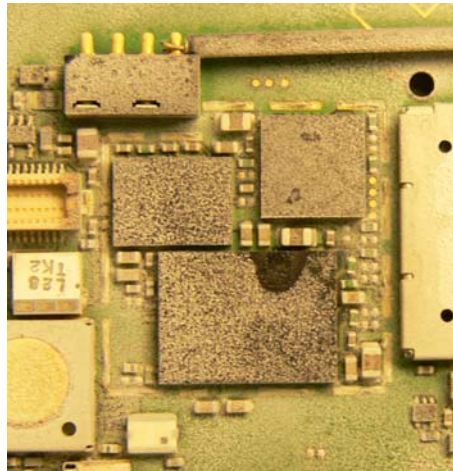
1.Example:

- BAT00 – radio draws about 400 mA in standby, no off current
- Q3401/U3000 are getting warm
- Q3401 provides VRF_TX_2.775V for PA via short resistor R801 (using Flensburg Layout Viewer)

- GSM-PA U800 is also getting warm (see above)
- U800 itself has an internal short. → defective U800

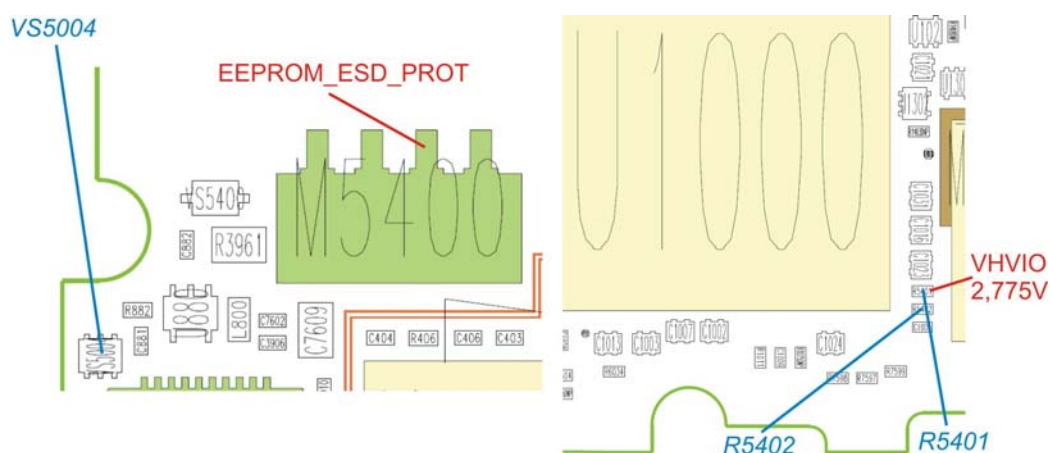
BAT04 – Invalid Battery

- verify EEPROM_ESD_PROT (M5400-2) while PCB is connected to EMU-USB cable. It should be 2.775V.
- If it is low, check VS5004, R5401 (4k7) and R5402 (100 Ohm). If they are ok it should be a problem with the POG U1000

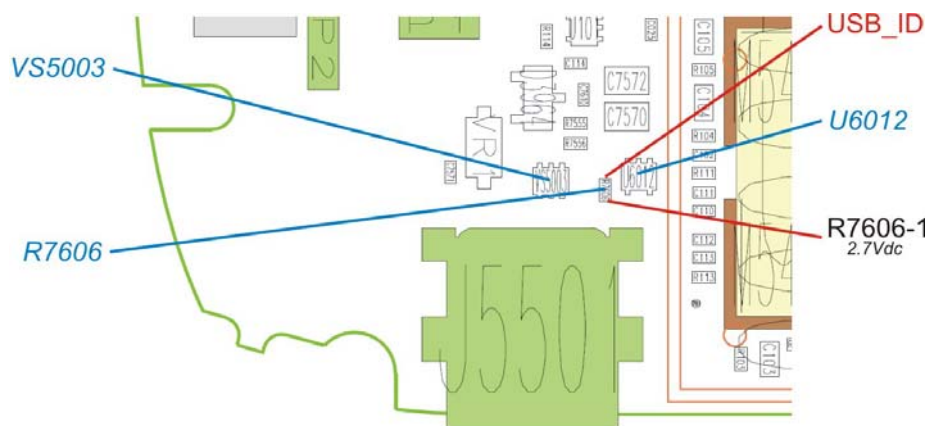
**CHG02 – No charging indication**

If display indicates “Charging not possible” or the phone only powers on while plugging in the charger, but is not charging. Then check the USB_ID line at J5501 with phone powered on by battery. It should be 2.7Vdc (2.4Vdc is **not** enough !)

- **If not** check VS5003. USB_ID voltage must be 2.7Vdc, if VS5003 is removed
- Check voltage at R7606-1 (2.7Vdc) and check U6012
- **If ok** replace U6003

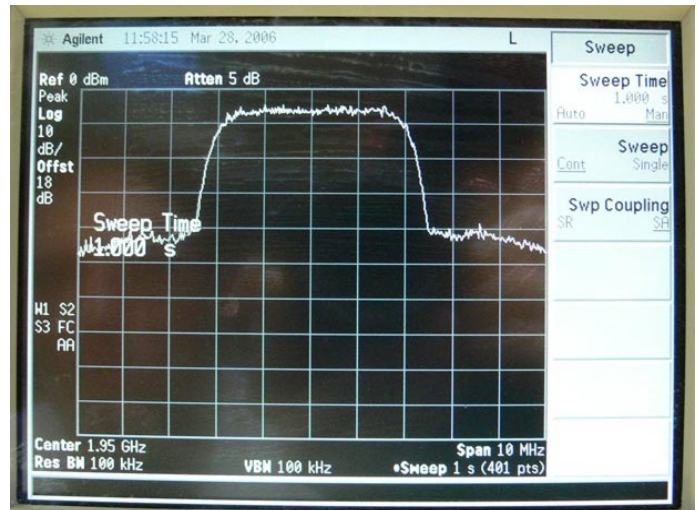
No TX WCDMA

Let radio transmit on WCDMA using Repair Studio/Radiocomm. Make sure to provide a battery voltage via micro clamp-type test probes to battery contacts M5400.

- Check WB_TX at C411 – if ok in size and form (if unsure compare to good radio) check FL003, FL001
- Size and form of WCDMA TX signal: (Analyzer set to: SPAN – 10MHz)

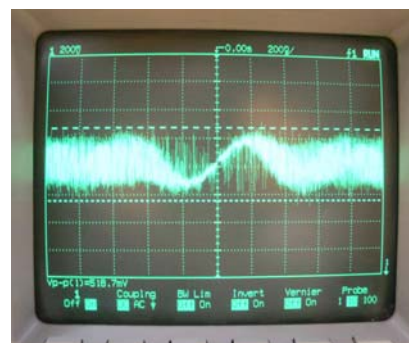
WCDMA TX I/Q signal

- **If not ok** check PA input at C221
- If PA input is good, check supply voltages VRF_PA_REF_2.775V at C402 and PA_BATT+ at C400/C802, TX_WB_EN at C403 about 2.7Vdc (WCDMA TX Enable signal from Harmony). If all of these signals are present, WCDMA PA U400 is most properly defective.
- **If PA input is bad**, check the signals to U200: TX_EN (2.7Vdc from Harmony) at TP205, SW_VCO_EN (2.7Vdc from Harmony) at TP210, REF (26 MHz clock from Blue Module) at R213.

Also check the TX I and Q signals. If all of these are present, it is most likely a defective or badly soldered Rattler IC (U200).

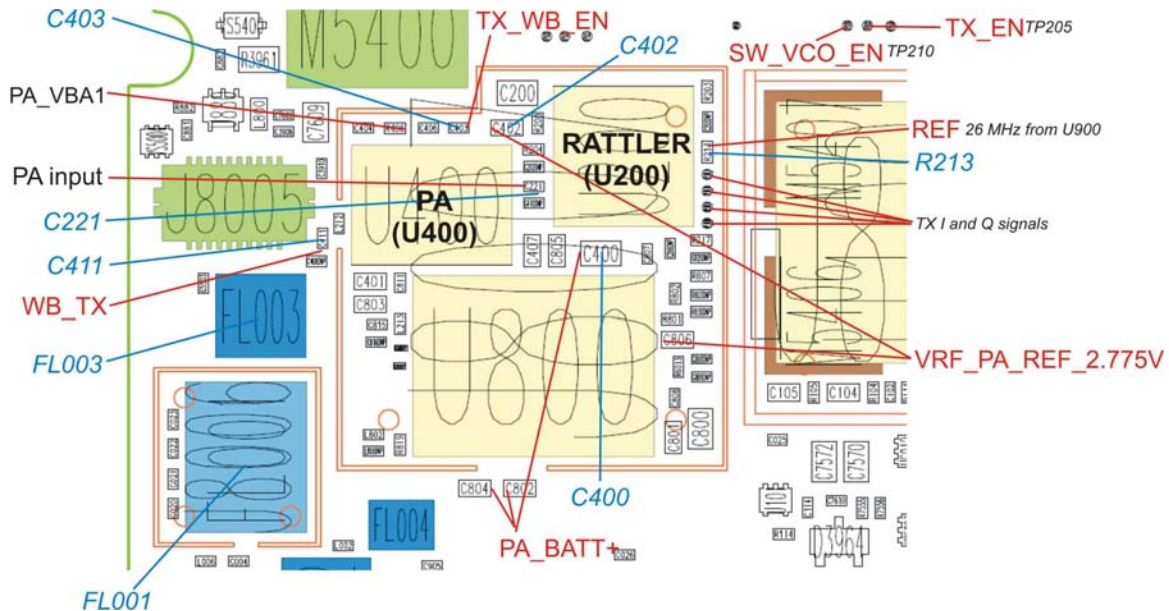
- If one of these signals (except 26 MHz REF) is missing, Harmony (U100) is most properly defective.

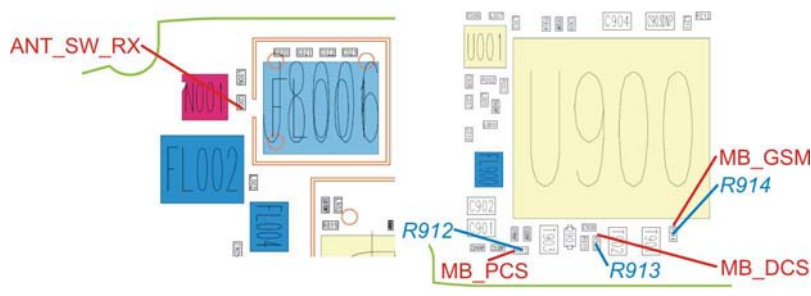
No RX GSM900 (1800/1900)

Inject a RF from Test Set. Check ANT_SW_RX at antenna switch N001-1. Check for presence of MB_GSM at R914 (MB_DCS at R913 / MB_PCS at R912).

- **If not ok** replace FEM FL001
- **If ok** there is most likely a problem with the Blue Module U900 or the Harmony U100

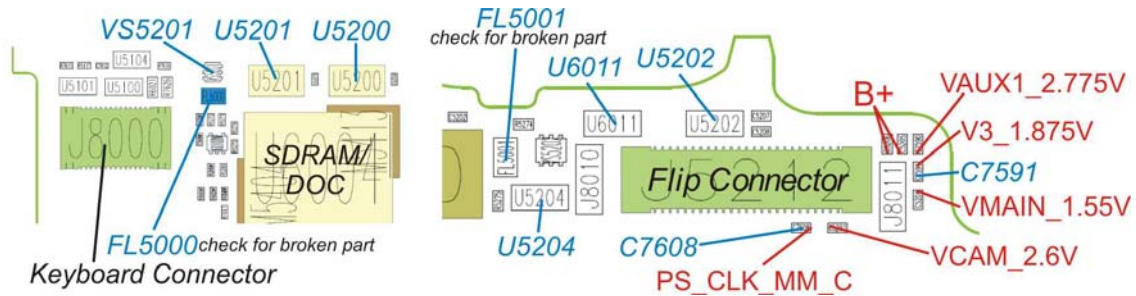
DIM01 – Display Main – no display**DIM08 - Display Main – No backlight****DIM09 – Display Main – Low/Dim backlight****DIS01 – Display Secondary – no display****DIS07 – Display Secondary – No backlight****DIS08 – Display Secondary – Low/Dim backlight****DAP10 – Data Application – poor picture quality**

Make sure that the problem is not located in the Flip Assembly, by testing PCB with a good one and do an optical check of J5212.

The following supply voltages for the Flip Assembly should be present:

- VCAM_2.6V at C5203
- V3_1.875V at C7591
- VMAIN_1.55V at C5204
- VAUX1_2.775V at C7590 (generated by Q3703)
- B+ at C5205/C5206

The voltages can be ok without a flip connected, but can break down, if a flip is plugged in, although the flip is ok! Additionally check the clock signal:

- PS_CLK_MM_C at C7608 (should be 13 MHz)
- only present the first seconds after power on!**

- Filters U5202/U5204/U6011 and Diode VS5201
- Filters FL5000/FL5001 (look especially for broken part!)

If ok, replace U5200 and U5201 (sometimes they are badly soldered only)

If all of these are ok, it should most likely be a problem with the POG.

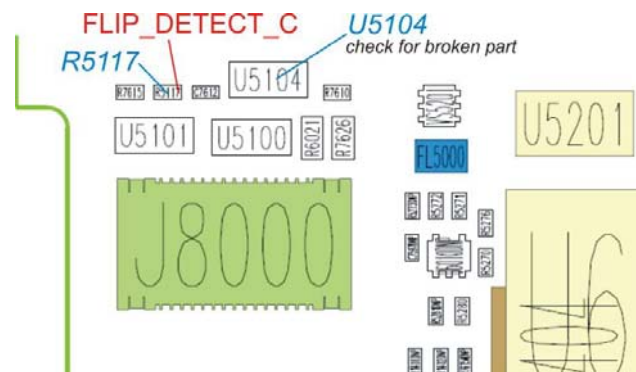
**DIM01 – Display Main – No display****MKP01 – Main Keypad – No Function/hangs****TON01 – Turn on/off – No turn on****Flip detect problem**

Units with a flip detect problem will show following symptoms:

- no power on via battery
- no main display via EMU connector supply
- CLI display is not switching on open/close flip
- no keypad function

Check FLIP_DETECT_C at R5117 – should be 2.7Vdc (High), if it is low check

- R5117 itself
- Check Filter U5104 for broken part/solder short
- Replace Filter U5104
- Check FLIP_DETECT_C at R5117 again
- If FLIP_DETECT_C is 2.7Vdc (High) now, the Filter U5104 was defective
- **If not**, the POG is defect

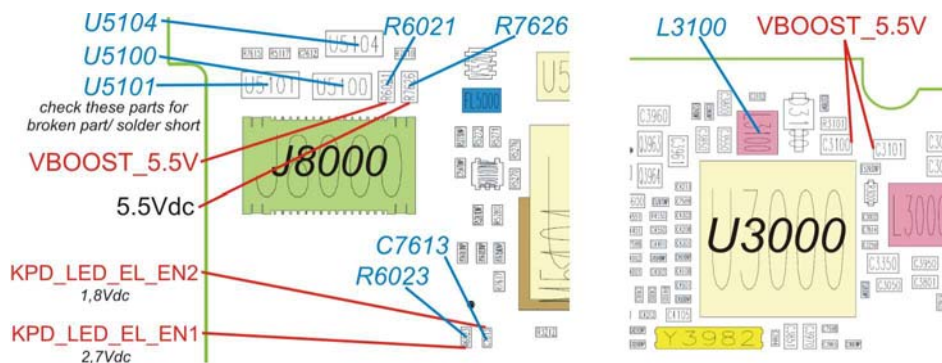
MKP05 – Main Keypad – No/Dim backlight

First check keypad connector J5100! Turn on keypad backlight using Repair Studio/Radiocomm. Check VBOOST_5.5V at R6021-1.

- **If not ok, only 4 – 5Vdc (same as B+) or high current with keypad connected,** check/replace L3100. If L3100 ok, replace PCAP (U3000).
- **If VBOOST 5.5V is ok,** check R6021/R7626 (5,5Vdc must be present at R7626-2 also)
- **If ok,** check KPD_LED_EL_EN1 (2,7Vdc) at R6023, KPD_LED_EL_EN2 (1,8Vdc) at C7613 with backlight turned on.
- **If not ok,** remove U5104 and check again. If ok, place new Filter. If not, POG (U1000) is defect.

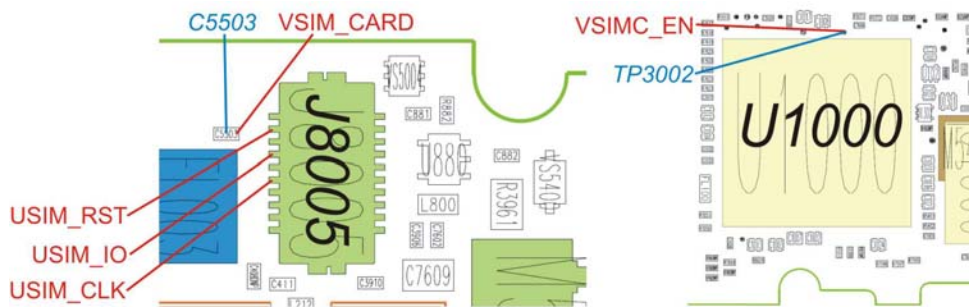
**SIM01 – SIM card – check card/insert SIM**

Measurement on the SIM interface is a little bit difficult, as not all signals will be present until a SIM card and a battery are inserted. As far as I know there is still no SIM feature implementation in Repair Studio or Radiocomm. In the most cases it should be possible to figure out which part is defective by simply using the Ohm Meter to measure the following signals to GND:

- VSIM_CARD at J8005-2,J8005-3, C5503-2, C3850

If far less than 30 kOhm to GND, it could be a defective PCAP (U3000)

- USIM_CLK at J8005-5
- USIM_IO at J8005-7

- USIM_RST at J8005-9, C3911-2

If any of these has far less than 30 kOhm to GND, it could be a defective POG (U1000). Before replacing the PCAP (U3000) or the POG (U1000) make sure that none of the associated capacitors have low resistance to GND.

The VSIM_CARD can also be checked with the oscilloscope. First put the probe to the test point (C5503-2) and then switch on the phone (by switching the output of the power supply). After a few seconds the VSIM_CARD (2,7Vdc) should appear for about one second. The same can be done with VSIMC_EN at TP3002. It is the enable signal for VSIM_CARD. While it goes to high level (2,7Vdc) VSIM_CARD is switched on.

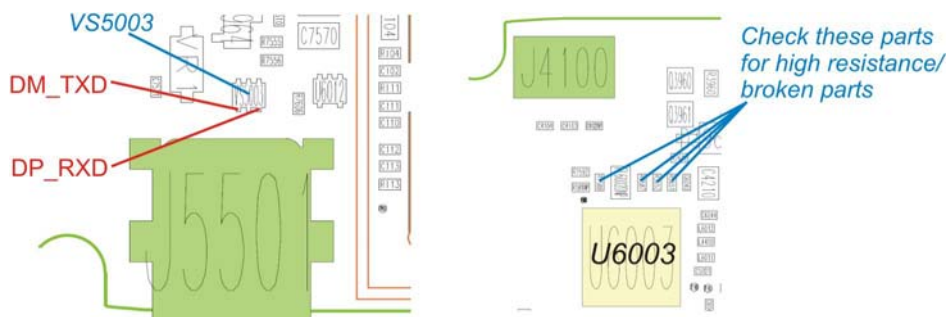
TON01 – No Turn On

Verify if radio doesn't turn on (assembled with display). If it does, but doesn't enumerate via EMU-Connector at RSD/Repair studio there should be a problem with the USB connection. In some cases a 1FF SW reflash in FORCED FLASH MODE (by connecting EMU-Connector to radio while "*" and "#" are pressed) can fix this issue.

- **If not,** visually check EMU Connector for mechanical defects or contamination on contacts, bad soldered pins or solder shorts
- Check the DP_RXD line at VS5003-3 (J5501-3) and DM_TXD line at VS5003-1 (J5501-2) with an ohm meter to GND to make sure, that there is no short to GND or an open track
- Check R3651, R3652, R7587, R7588 for high resistance
- **If ok,** replace EMU-chip (U6003)
- Check again
- **If not ok,** the POG (U1000) is defect

The USB interface is located in the POG, but the data bus is switched through by the EMU-chip (U6003).

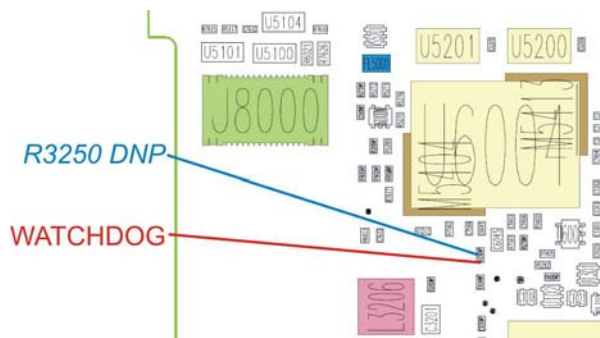
Note:

- Watchdog

In case the phone draws current but switches off after a few seconds, you can force the phone not to switch off, by setting the **Watchdog R3250DNP**. By placing a short resistor as R3250, or by just solder across the pads of R3250 the WATCHDOG signal will be pulled to HIGH (VLVIO_1.875V) and the PCAP will not switch off its power regulators. You will then be able to measure all the voltages or to do a thermal troubleshooting by using ice-spray.

- "power switch"

The second way to check the voltages is to use a switch in the plus line of your power supply. You can put the probe to the test points of each voltage and view the voltages appearing for a short time (half a second) during each switching action.

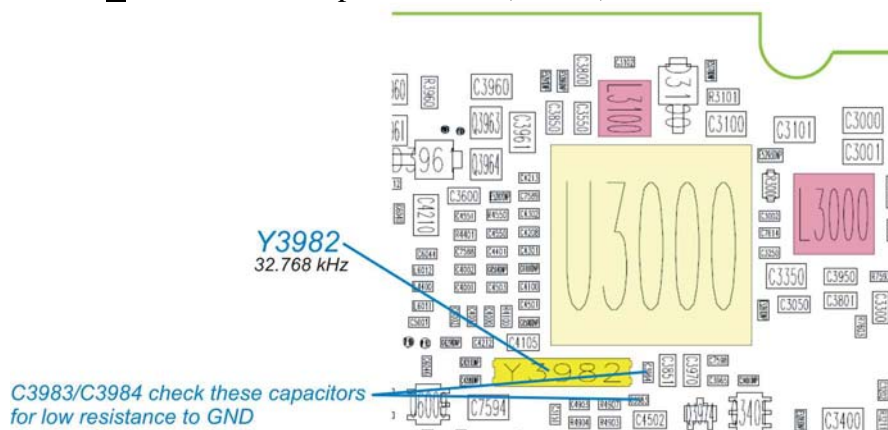
If radio draws no current at all (also not for a short time) it's most likely a problem with the 32.768 KHz clock generated by Y3982

- replace Crystal Y3982
- **if** unsuccessful, replace PCAP (U3000)

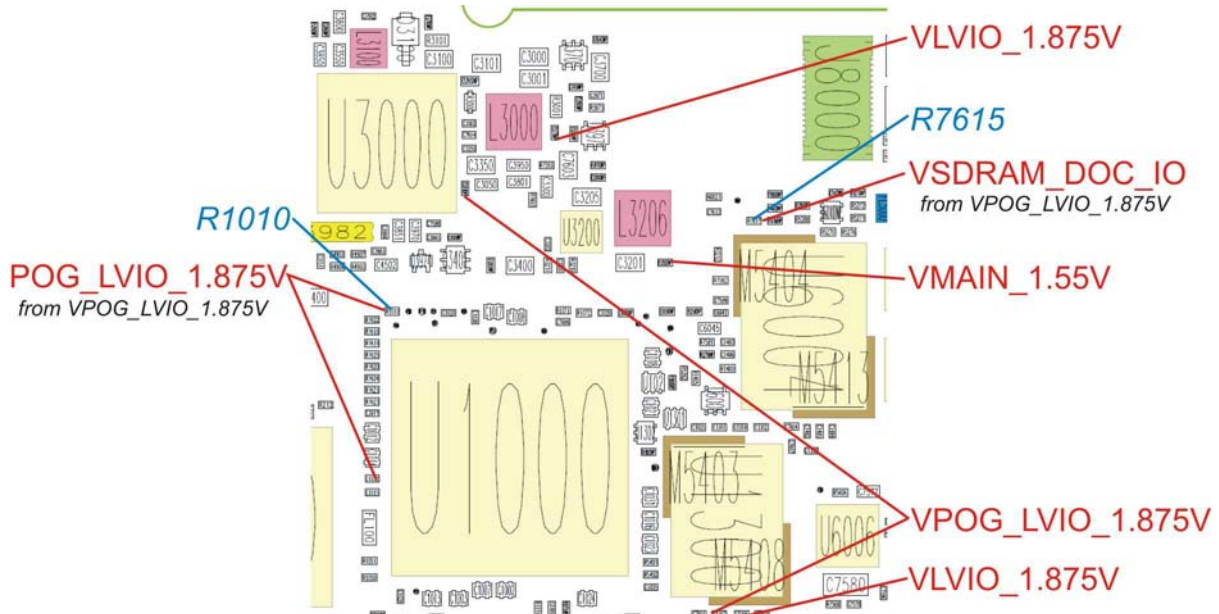
If the phone doesn't enter flash mode, but draws current the following signals should be checked:

- VPOG_LVIO_1.875V which becomes POG_LVIO after passing short R1010 / VSDRAM_DOC_IO after passing Short R7617
- VLVIO_1.875V which is only used for FLASH / SDRAM and Harmony
- VMAIN_1.55V
- 32.768KHz clock at Y3982

If one of them is missing or low, check current consumption. If it is high something might be getting warm – follow the thermal troubleshooting routine as described in the **BATxx** section of this document.

Otherwise replace PCAP (U3000).

If voltages are ok, FLASH and POG already replaced and the USB-bus is checked, but phone appears as a “unknown device” for the computer, it is most likely a problem by the SDRAM/DOC (U6004).

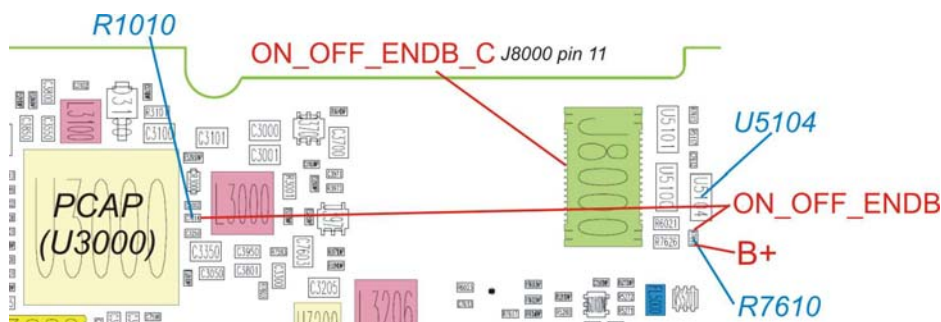
TON01 – Turn on/off – No turn on

TON06 – Turn on/off – No turn off

**MKP01 – Main Keypad – No function/hangs (On/Off switch)
On/Off switch not working**

Check U5104 for broken part/solder short and make a visual inspection of J8000. If it seems visually ok, there might be a defective part.

- Check voltage at ON_OFF_ENDB_C (J8000-11). It should have same level as B+ (for example: 4Vdc)
- **If not ok**, check ON_OFF_ENDB at R7610-2 (same level as B+)
- **If ok**, replace U5104
- **If ON_OFF_ENDB is not ok**, check R7610 and C7614
- **If ok**, replace U5104
- **If unsuccessful**, replace PCAP (U3000)
