MOTOROLA

Doc. No: TSG_V360

Title: Troubleshooting-Guide V360

V360 Debug-Guide

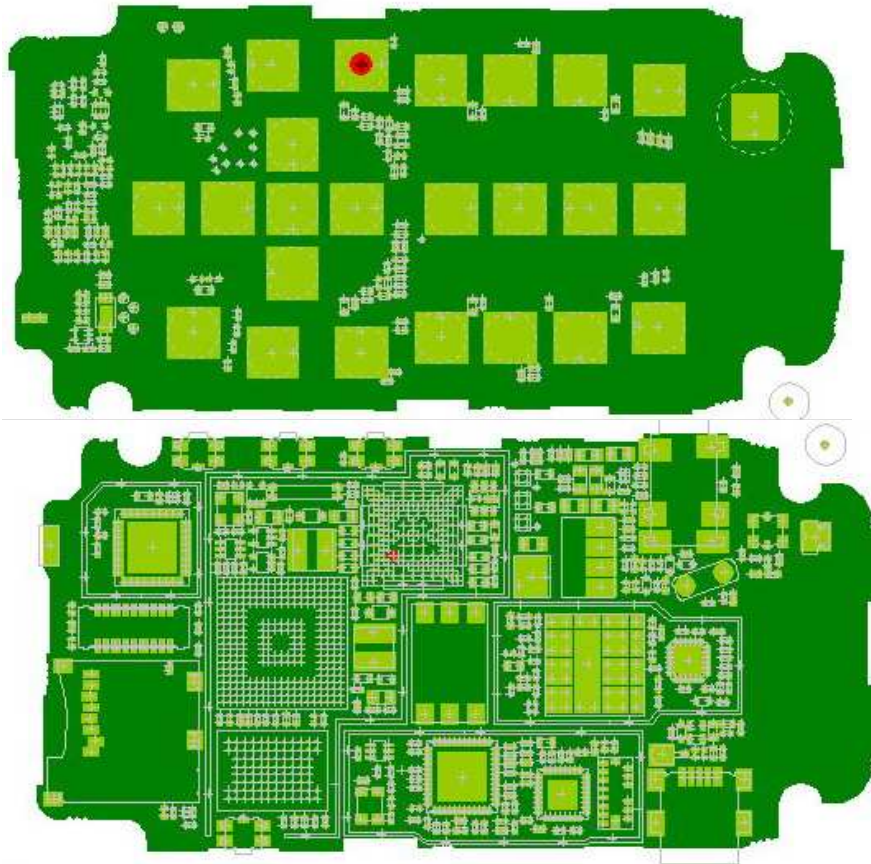
TON00:

Phone is starting up via Mini-USB, but doesn't start via battery

There is only the **ON1B** connection between On/Off Button (S514) and Atlas (U900)

Defective Part: U900

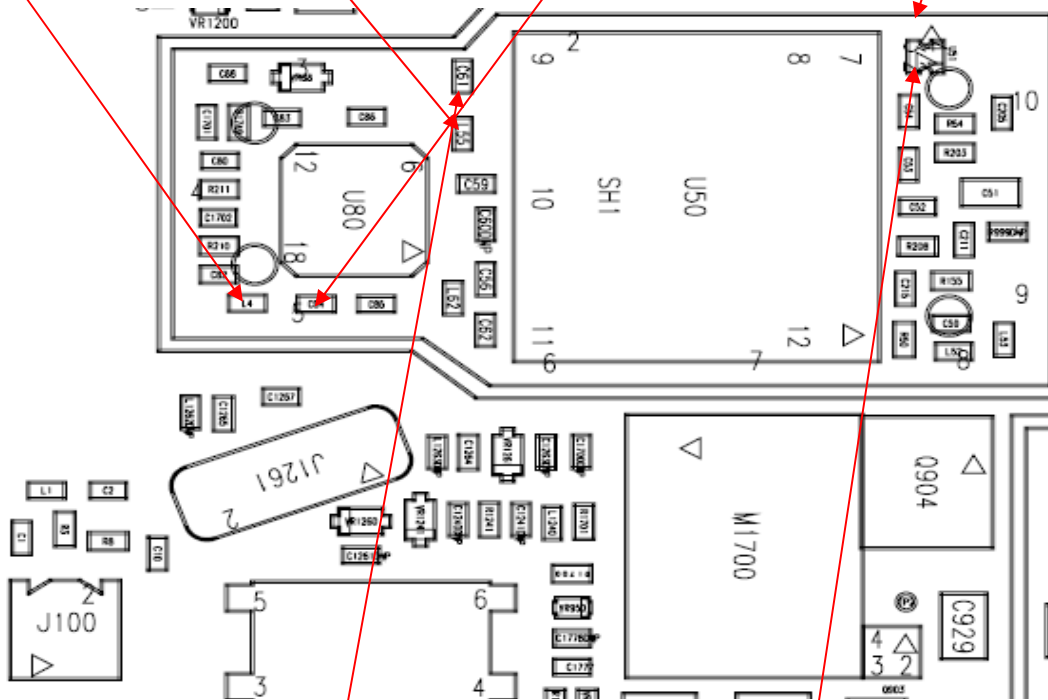
CPR01

CPR01:

Manualtest failed at **GSM 850 PA Phase PS06**

min 30dBm
max 36dBm
result 14.31021dBm

TX-Signal at U50 IN	good
TX-Signal at U50 OUT	good
TX-Signal at U80 IN	good
TX-Signal at U80 OUT	bad/low

Defective Part: U80

Input TX V80 (Antenna switch)

Output TX U80

L4

Click Shild SH1

Output U50 (PA)

Input U50 (PA)

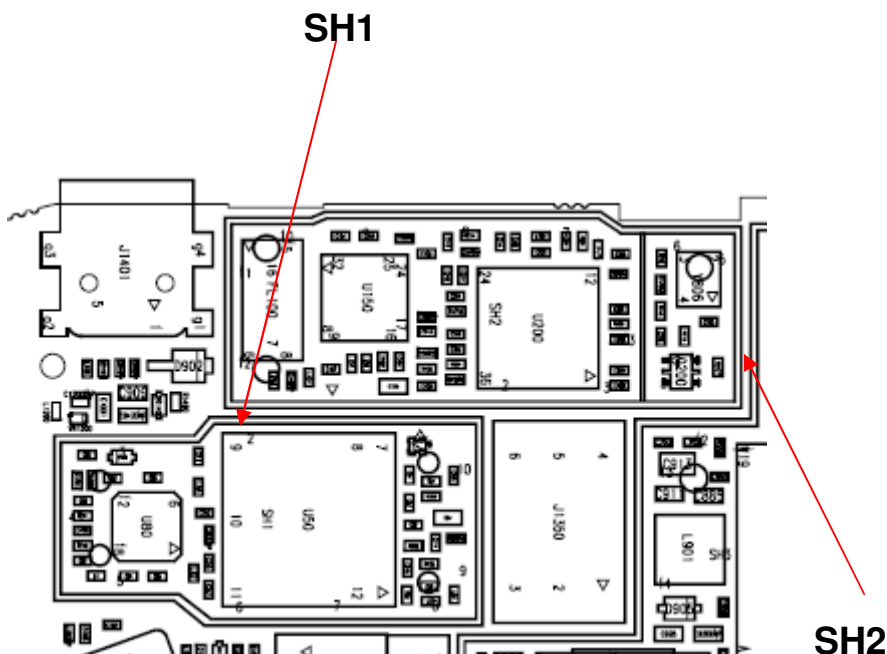
CPR00

Phone can't make calls. Tx VCO U200 oscillates. Remove "click-shields (SH1, SH2), for detailed measurements (see picture below). At M1730 (antenna connector) no Tx signal, at L4 Tx signal ok, replace J100 (see picture above).

Phone can't make calls. Tx VCO U200 oscillates. At M1730 (antenna connector) no Tx signal, at L4 (behind U80) also no signal, at L55 (input U80) Tx signal ok, replace U80.

Phone can't make calls. Tx VCO U200 oscillates. At M1703 (antenna connector) no Tx signal, at L4 (behind U80) no signal, at L55 (input U80) no signal, at C61 (output PA) also no signal, at U51 (input PA) Tx signal present, replace U50.

Phone can't make calls, Tx VCO U200 doesn't oscillates, replace U200.

Tip: See field Service Bulletin BJCCFSB2005-233

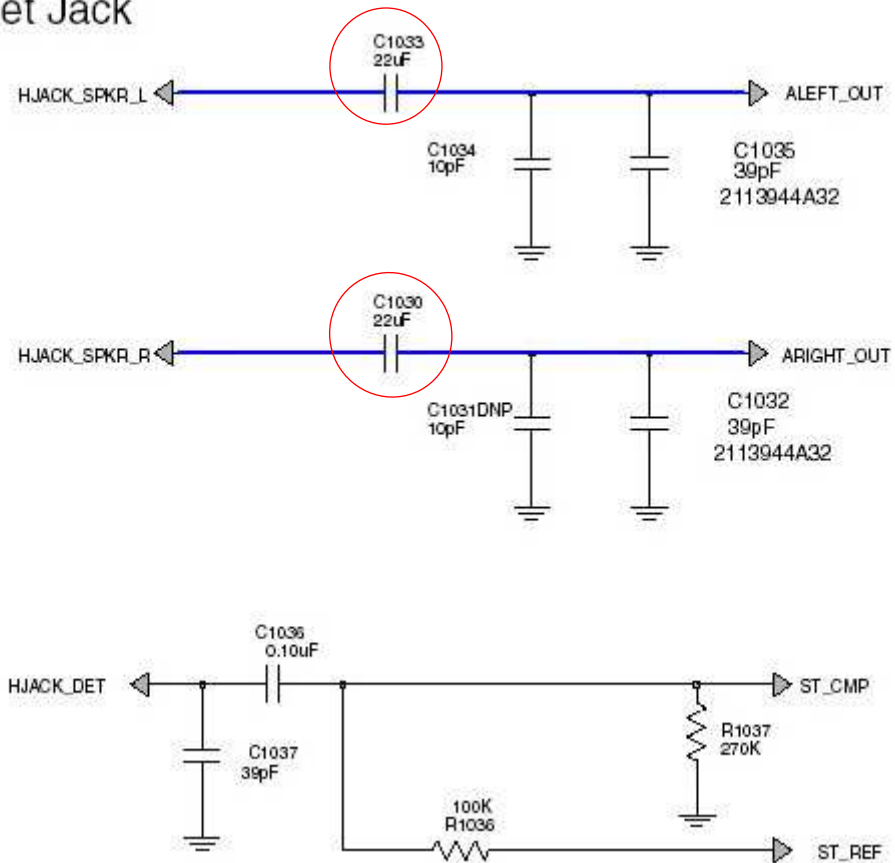
Headset Jack

CPR00

- no MIC or SPKR
- sounds in multimedia menu don't start
- no audio in call

C1033/C1030 defect

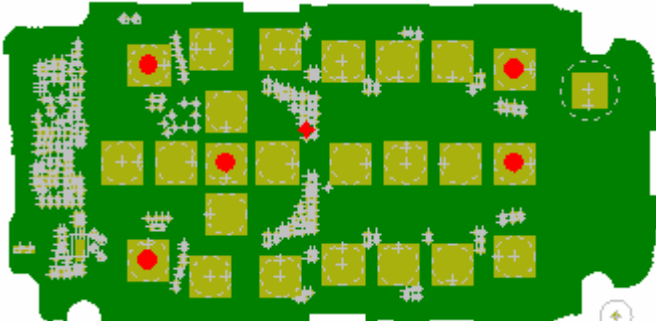
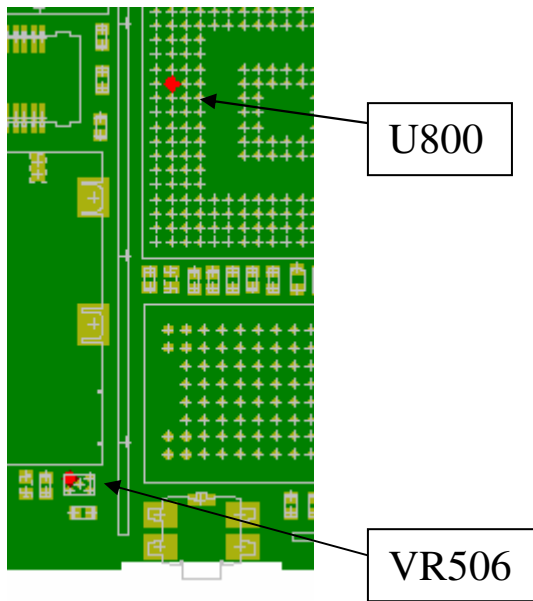
MKP00

The shown keys didn't work:

VR 506 was broken. It is connected to U800 pin H2 and the keys shown above.

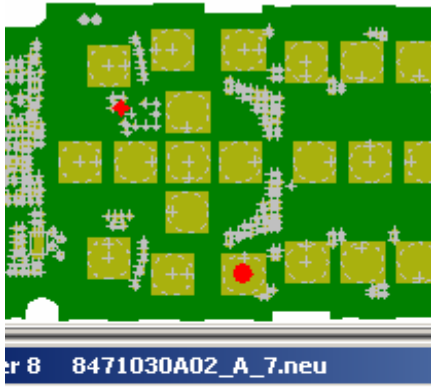
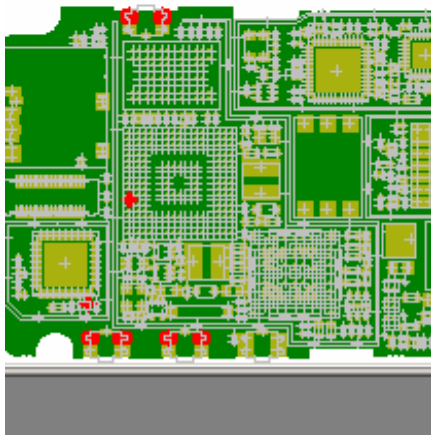
MKP00

Level 4 keypad problem

- following keys are affected (shown with FL View):

- they all have KBR05 in common, VR508 is not placed , VR505 should be ok, because KBR0/KBR4...are ok
- U800 is defect

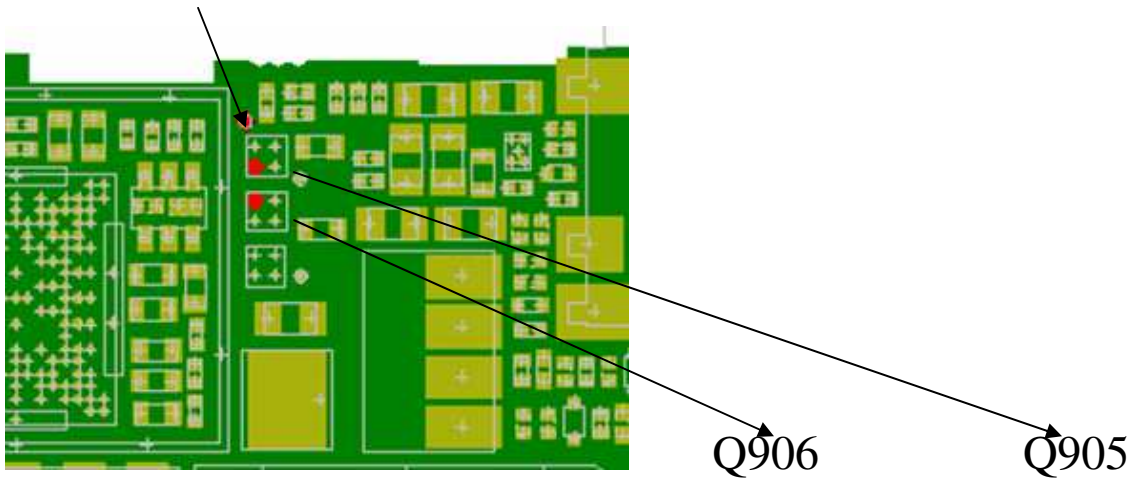
CHG00

FLX_BATT	Store battery phasing table	0	0	0 err	P
BATTLCCR	Battery Meter Low Current	-2000	11,60865	2000 mA	P
CHG_LCCR	Charger Supply Low Current	128	38,892625	234 mA	F
BATT_LOW	Battery Meter Low DAC	975	1004	1015 DAC	P
BATTHCCR	Battery Meter High Current	-2000	11,5687	2000 mA	P
CHG_HCCR	Charger Supply High Current	718	36,145725	1073 mA	F
BATT_HI	Battery Meter High DAC	820	1003,8125	896 DAC	F
BATMGAIN	BATTERY METER SLOPE	110	5	146 DAC	F
BATTMOFS	BATTERY METER OFFSET	-10	3	30 DAC	P
BATTPHSE	BATTERY METER PHASE	-20	0900390625	20 N/A	P
BAT_STAT	BATTERY PHASING STATUS	0	1	0 N/A	F
BAT_SENS	Main Battery Sense read back Voltage wit	.1	1,767890625	2,25 volt	P

affected parts shown with FL View:
 testpoint(TP7/4.2V) , connection Q905 drain(pin 4) to Q906 (pin 4)
 drain

Q905 was skewed part. Pin 3 was on the position of pin 4 and shortened the line.

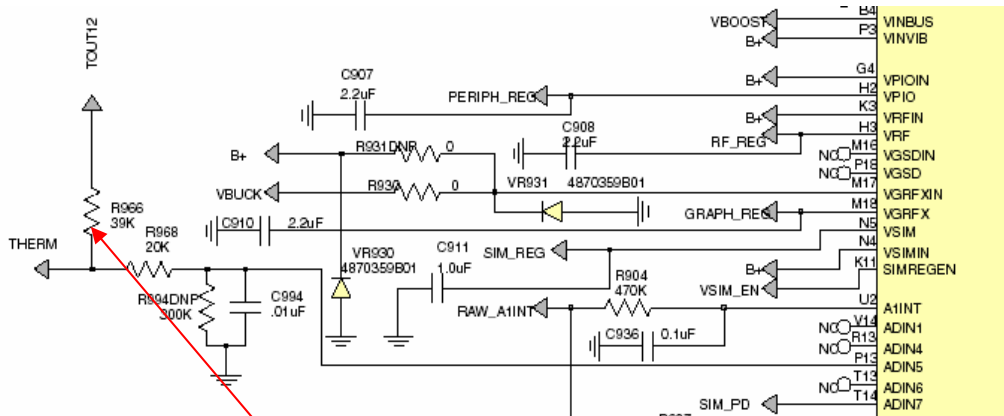
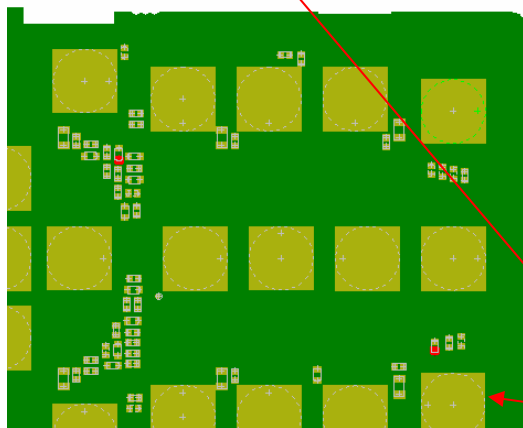
CHG00

- connect charger : „unable to charge“
- 2.8V on pin2 and pin3 of battery connector is ok (this bias voltage is supplied by U800 TOUT12 at pin U10)
- Gate passed because BATT_THERM is not implemented, but failed NexTest with

HON_THRM	Batt Therm Hi batt Chrg On	125	47	178 DAC	F
FLX_BATT	Store battery phasing table	0	1	0 err	F
HON_THRM	Batt Therm Hi batt Chrg On	125	34	178 DAC	F

- found an unsoldered resistor in the thermistor line R968 :

R968 (THERM) located the keyboard side of the pcb
