B2X Service Repair Information:	Reboot issue displaying “optimizing apps”
Info ID:	SRI-EMEA-2015-13_rev2
Countries:	EMEA
Carrier:	-
Repair Level:	L2
Affected Models:	xPlay / Nexus6 / XT1100

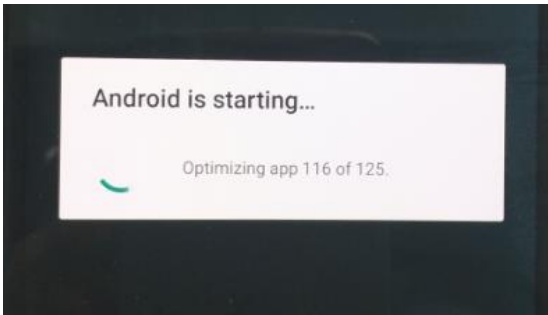
This process document will give instruction of Nexus6 flashing process when customer devices returned for repair with a reboot issue by optimizing apps displayed in the phone.

MASC have to perform board swap !
