Date: 2015-01-29

B2X Service Repair Information:	Swollen batteries on Nexus 6
Info ID:	SRI-EMEA-2015-03_Rev4
Countries:	EMEA
Carrier:	-
Repair Level:	L1 swollen battery Swap action - L2 Rework Action
Affected Models:	XT1100

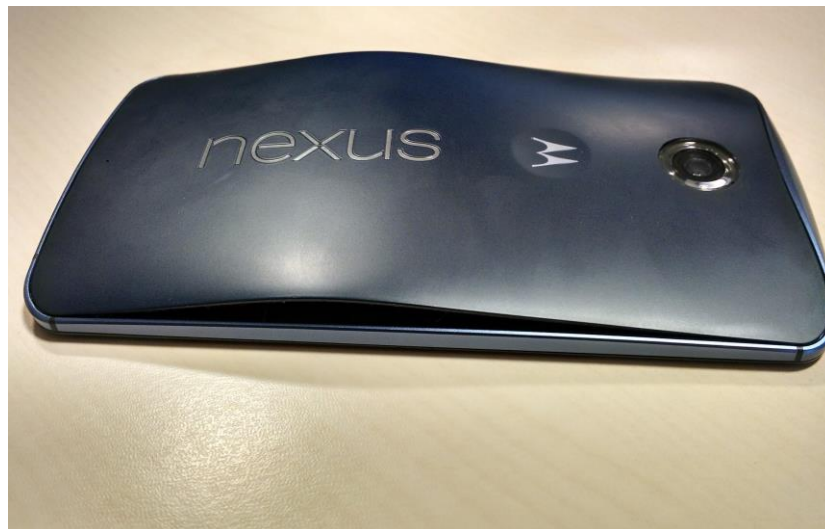
The root cause for lifted battery cover and expansion of the battery has been identified and appropriate repair actions have been introduced. Motorola has confirmed that this is material related and not due to how people use their phones, and does not pose a safety concern. The problem may be seen with a very slight lift of the rear inlay cover.

1. NEXUS 6 devices returned for swollen battery issue shall be swapped out and the defective device shall be quarantined for possible parts harvesting, RTV process or final scrap.
IMPORTANT: All swollen battery cases must be replaced with reworked devices. Make sure not to use any unscreened/unmodified stock.
2. NEXUS 6 devices returned for any other issue (including NFF) and with a month of ship prior to January 21st 2015 units shall be repaired accordingly and additionally inspected for Factory Rework Marking.

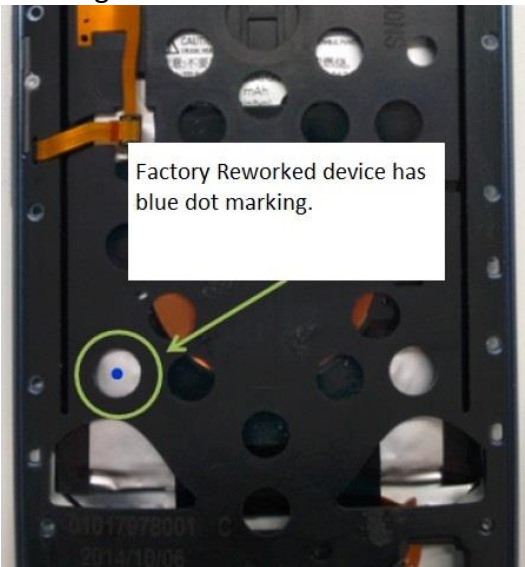
1. Following the Service Manual document, carefully disassemble the device.
2. After removing the Rear Cover Inlay (p/n: 0101805700x) inspect the device for Factory Rework Marking as shown below. If the device already has a factory marking, following steps do not apply.

If the device does not have a blue dot marking, continue the action as follows
