## FIELD SERVICE BULLETIN

FSB Number: LVCCFSB2005-226 (Informational)  
Author: Ross Karlen  
Date: June 29, 2005  
Total No. of Pages: 3  
Subject: **3G A1000 M1000 – Master Clear Key Sequence**  
Model Affected: 3G A1000 M1000  
Level of Repair: 1

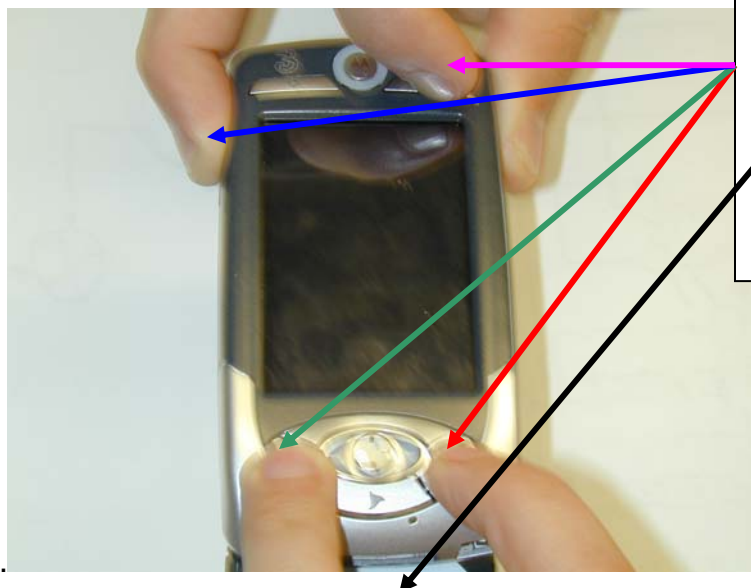
(A1000 pictured)  
**STEPS**  
1. Hold Down **Send, End, Volume Down, and Game-B** Key.  
2. Slide Battery in with Left Thumb  
(See FIG 2)

While depressing the Send, End, Volume Down, and Game-B key, Insert the battery FIG 1. Expected Result: The phone will start powering up, then reset, perform Master Clear, and then power up to an active state. (Note: This Master Clear will operate the same as if you used the Master Clear in the menu options)
