FIELD SERVICE BULLETIN

FSB Number: BJCCFSB2004 - 211
Author: Xu Changhong
Date: 8 November 2004

Subject: **GSM EZX (A780) Keypad no function due to G-Flex broken**

Model Affected: **EZX (A780) Quad Band**

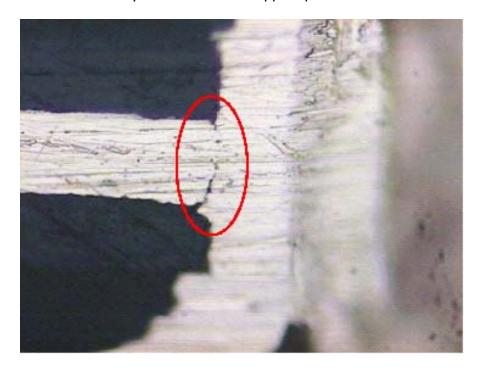
Fig. 1

During the A780 NPI analysis the <u>"Keypad no function"</u> is highlighted as the Top #1 issue which accounts for 10% of Octobers field returns. Supplier FA report show that the <u>"(G-) flex cable broken"</u> resulted in the keypad no function.

Figures 1 &2 illustrate the detailed failure mode. There is a narrow slot at the junction area of that is between the hole and the nearby circuit. This is a supplier process issue.

- 1. All the old date code parts (before 4004) should be scraped in Gflex
- 2. In the Gflex new process the PTH is adopted for the new date code parts building instead of the old process (shadow)
- 3. Old assembled parts were purged in TOEC at the end of Sep. From wk42, TOEC started using the parts with **new date code 4004**

If a A780 phone is returned to a Service Centre for repair with the Customer Complaint of "keypad no function", please first verify that the symptom is only related to the keypad and is not related to the touch screen, then replace a new flip part with **new date code 4004** or later.
