**FIELD SERVICE BULLETIN**

FSB Number: LVCCFSB2003-90  
Author: Dale Jenkins  
Date: September 29, 2003  
Total No. of Pages: 2  
Subject: **A920 (Paragon) Headset Detect/Undetect Issue**  
Model Affected: All A920 (Paragon)  
Level of Repair: 3, and 4

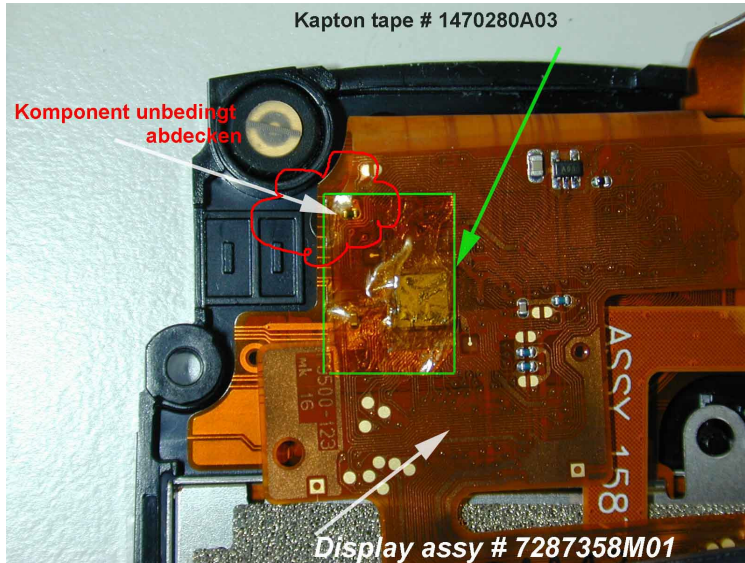
Customers may complain of headset not working or headset detect/undetect failures. This can be caused by an exposed resistor (Reference designation R206) on the display flex. The resistor grounds the sense line for headset detect/undetect. The failure can be intermittent.

Manufacturing has begun placing Kapton tape (part # 1470280A03) over the resistor on the display flex as per photo on page 2.

- 1.) Check to see if there is tape on display flex as shown in photo. If tape is there go to step (A), If not taped go to step (B).
  - a. Inspect tape for wear and tear or abrasions, replace with new tape (part # 1470280A03) if any are found. If no issues found with tape, proceed with normal troubleshooting procedures.
  - b. Place tape (part # 1470280A03) on display flex as shown in photo, reverify failure. If headset detect/ undetect failure persists' proceed with normal troubleshooting procedures.
