**FIELD SERVICE BULLETIN**

FSB Number: LVCCFSB2005-130  
Author: Rajesh Verma  
Date: April 20, 2005  
Total No. of Pages: 3  
Subject: GSM C115 Power Down When Pressing Navigation Keys  
Model Affected: C115/116  
Level of Repair: 2, 3, 4

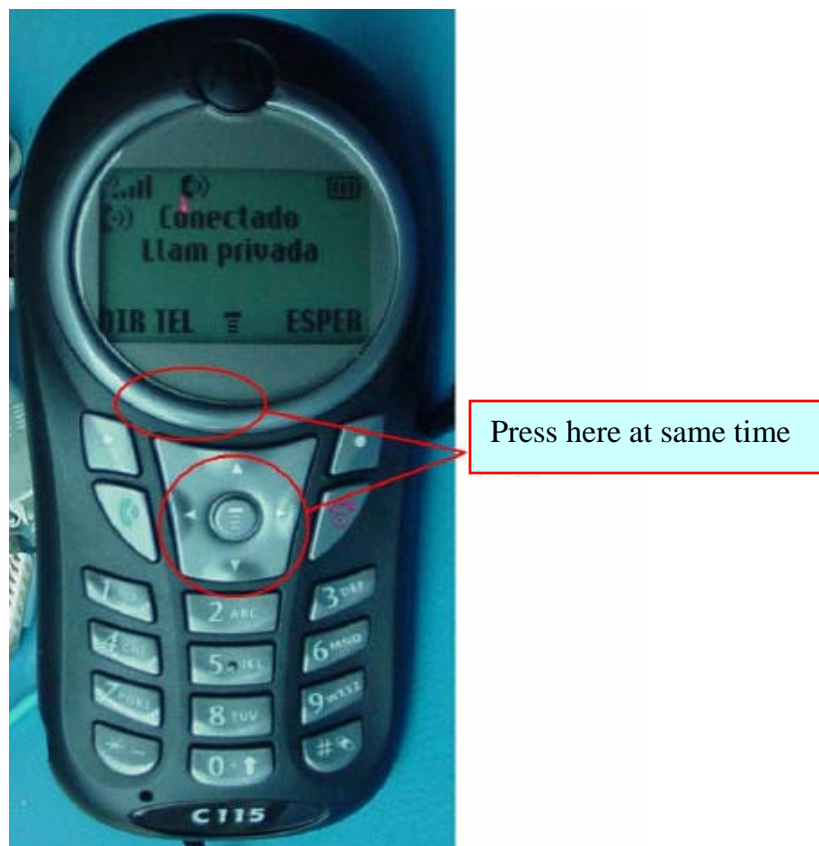
Fig: 1

Service is aware of an issue, identified from the field, on GSM C115/116. Some units returned with a customer complaint of “Power down” when the Navigation keys and display bezel is pressed simultaneously as shown in Fig 1 below. Capacitors on the PCB can short the RF shield when this occurs. These capacitors are identified in Figure 2. Customer will have to remove then reinsert the battery again to turn the unit back on.

1. Press the Navigation keys and display bezel as shown in Fig 1 above to verify the customer complaint.
2. If unit powers down, remove and reinsert the battery to turn the unit back on
  - a) If unit turn on, remove the RF shield and place a Kapton tape as insulator as shown in Fig: 3 above.
3. Reassemble, and then Retest the unit per the Customer Complaint to verify unit is repaired and does not exhibit failure symptoms.
  - a) If unit is not repaired by the insulating process, then proceed with normal troubleshooting techniques as per the customer complaint.

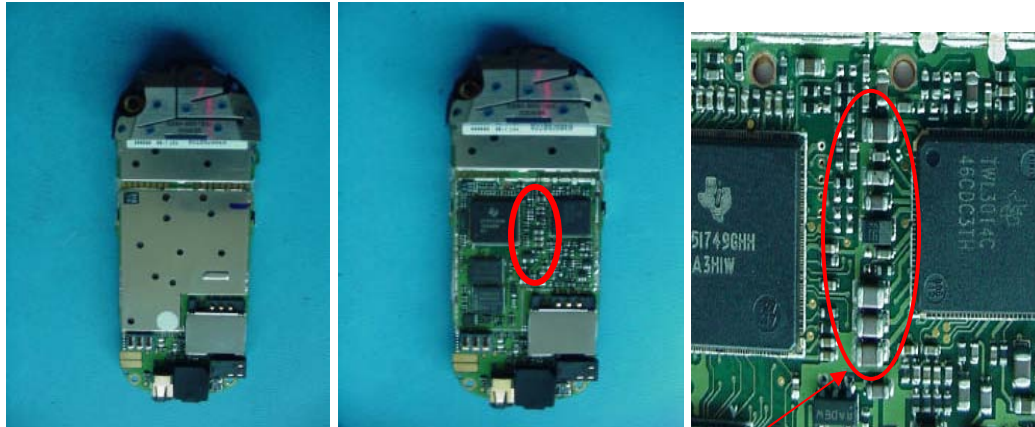
Fig: 2

These capacitors may short to shield when Navigation keys are pressed.

Factory implemented a Work Instruction to place a Kapton tape on the RF shield above the capacitors to act as an insulator. See Fig 3.0 below where Kapton tape is placed.
