FIELD SERVICE BULLETIN

FSB Number: BJCCFSB2005--81
Author: Jason Wang
Date: 21th Mar. 2005
Total No. Of Pages: 2
Subject: **C155/C156/C157 Skyworks PA Issue**
Model Affected: **C155/C156/C157 GSM/DCS**
Level of Repair: 3

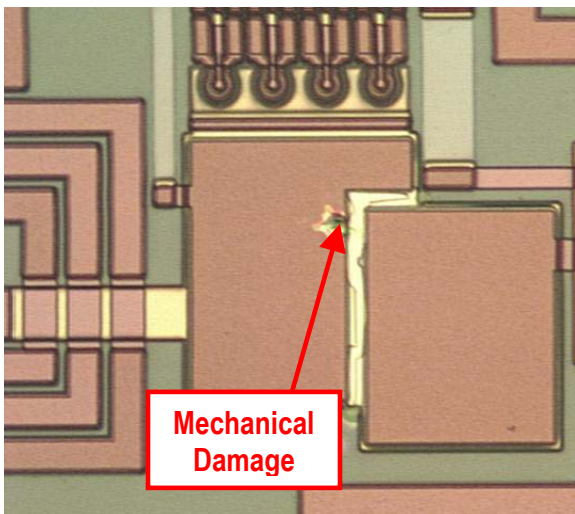
Pic.1

Service is aware of an issue identified during the 1st 200 NPI analysis on C155/C156/C157. Some units, returned with a customer complaint of "Can't Power on" or "Battery short life". This issue is caused by abnormal high current consumption of Skyworks PA P/N 0427732401W due to a mechanical scratch across the die surface. Such damage would lead to a short to ground on the die surface after phone assembly and field operation.

- 1), Added Cleaning After GaAs Die Scribe and Break Process.
 - 2), More Frequent Cleaning of the Pick up Tip (After Every Lot), Replacement of Pick up Tip (After Every 17,000 Placements).
 - 3), Heightened Wafer Inspection (100X Microscopic Inspection of Panels After Die Attach – for Lot Set-up) Added to Improve Overall Product Quality at all Assembly Sites.
- The actions are from week49.2004. Date code 0449.
