FIELD SERVICE BULLETIN

FSB Number: BJCCFSB2003-85 Rev (B)
Author: Cao Yin Yu
Date: Feb 25, 2003
Total No. Of Pages: 3
Subject: **GSM C35XV No Charge or No Power Up Rev (B)**
Model Affected: C350, C359, C350V, C359V, C250, C260, C266, C375, C450
Level of Repair: 3

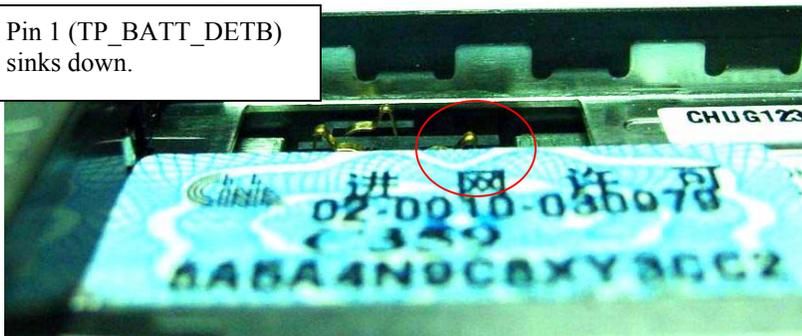
The issue was due to battery contact (M100) pins deformed/sinking down. Customers improperly insert battery cause battery contact pins sink down. Due to the same battery contact design, the affected models are C350, C359, C350V, C359V, C250, C260, C266, C375 and C450.

- If battery contact pins are not able to contact battery at all, phone does not charge or does not power up.
- If battery contact pins are not able to contact battery intermittently, phone also does not charge or does not power up intermittently.
- If Pin 1(TP_BATT_DET B) sinks down, the phone does not charge.
- If Pin 2(GND), pin 3(ATH_B+) sinks down, the phone does not power up.

Pin 1 (TP_BATT_DET B)
sinks down.

The new contact design was qualified (P/N: **3986859P01**).

Any No Charge/No Power Up failures of C350, C359, C350V, C359V, C250, C260, C266, C375 and C450 should be check whether the battery pins sink down. If the battery pin sinks down, the new design part M100 (P/N **3986859P01**) should be replaced.
