FIELD SERVICE BULLETIN

FSB Number: EICCFSB – 20
Author: Paul Convery
Date: 1st April 2003
Total No. Of Pages: 2
Subject: **9.6 kbps SIM card not compatible with C350**
Model Affected: C350
Level of Repair: 3/4

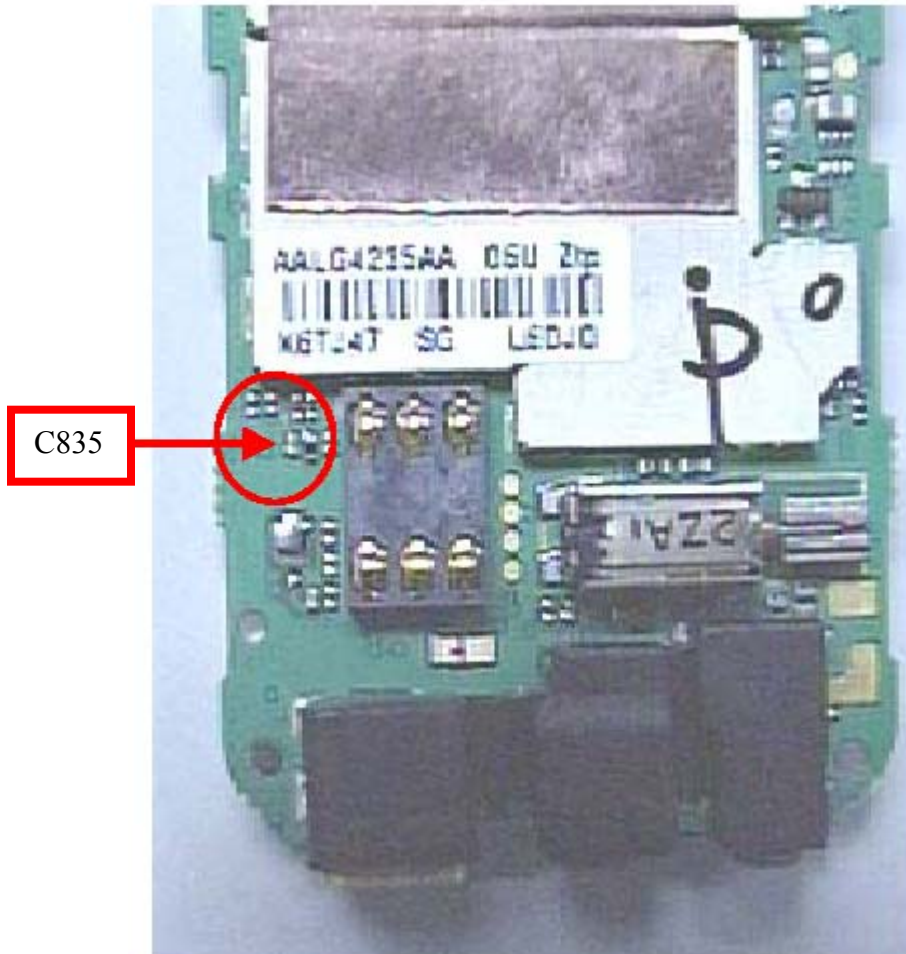
Fig1

There have been customer complaints of **Main Keypad No Function, Auto Power Down, and Check Card/ "Please Wait"** on the C350 product.

As a result of the C350 NPI analysis, it was established that a SIM card with a data transfer speed of 9.6kbps has difficulty in communicating with the C350 product, resulting in the above failure modes being seen.

The Design group determined that by removing C835 ([Part No 2113743L17](#)) from the PCB, the issue would be resolved.

Any radio returned for repair with a customer complaint: Main Keypad No Function, Auto Power Down, and Check Card/ "Please Wait" should remove C835 from the main PCB. Please see fig 1 for details.
