FIELD SERVICE BULLETIN

FSB Number:	LVCCFSB2004-113
Author:	Max Dekirmandjian
Date:	May 21, 2004
Total No. of Pages:	2
Subject:	No/Intermittent/Noisy Mic Audio on TA02 GSM Products
Model Affected:	C236, C250, C260, C33x, C450, C35x, C370, C380,
Level of Repair:	1
Model Affected:	•

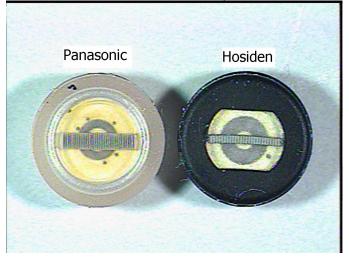
Service has been made aware of an audio issue pertaining to the microphone 5089725K04. There have been customer complaints from the field related to the TX/Mic audio when Panasonic mics are used. This was also confirmed during the C350 MOL analysis. In many cases, proper Mic audio operation can be temporarily restored by applying pressure to the front housing near the mic location. The root cause has been determined to be deformation of the elastomer boot used on the Panasonic mic which results in a no or intermittent connection between the Mic to PCB contacts. Microphones manufactured by Hosiden do not exhibit these failures. The elastomer boot on Hosiden mics is a different design. Compression testing of these microphone assemblies found that the Panasonic mic required a greater load than the Hosiden samples to reach comparable resistances across contacts of a test board.

Panasonic vs Hosiden Mics (viewed from contact side)

Microphones manufactured by Hosiden should be used in place of Panasonic. Part # is 5089725K04.

- A) No or intermittent mic audio
- B) Static or noisy mic audio
- C) Poor call quality (if the mic is suspected)
- Analysis Procedure:
 - 1) Disassemble the unit to gain visibility to the mic
 - 2) Verify the type of mic being used. Refer to the photo below to aid in distinguishing between the two mics:
 - 3) If a Panasonic mic is being used, replace it with a Hosiden.
