FIELD SERVICE BULLETIN

FSB Number: LVCCFSB2004-153
Author: Max Dekirmandjian
Date: July 16, 2004
Total No. of Pages: 2
Subject: C380 Rear Housing Opening Instructions
Model Affected: C380
Level of Repair: 1

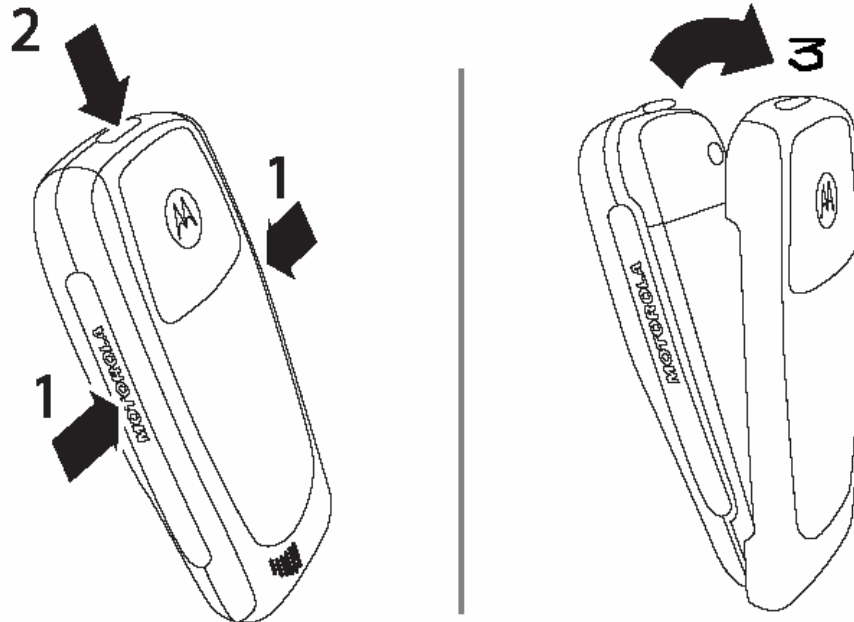
C380 users & service personnel are experiencing extreme difficulty in removing the rear housing.

Use the following procedure to remove the rear housing as necessary on customer returns. Refer to the diagram below.

- 1) Squeeze the sides of the front housing in the middle of the "Motorola" logo as shown in the diagram;
- 2) Simultaneously press the release button on the top of the phone with the thumb of your free hand;
- 3) While implementing Steps 1 and 2, pull the rear housing away from the phone.
