### **FIELD SERVICE BULLETIN**

FSB Number: LVCCFSB2004-190  
Author: Max Dekirmandjian  
Date: September 27, 2004  
Total No. of Pages: 3  
Subject: C380 Cracked Rear Housing  
Model Affected: C380  
Level of Repair: 1

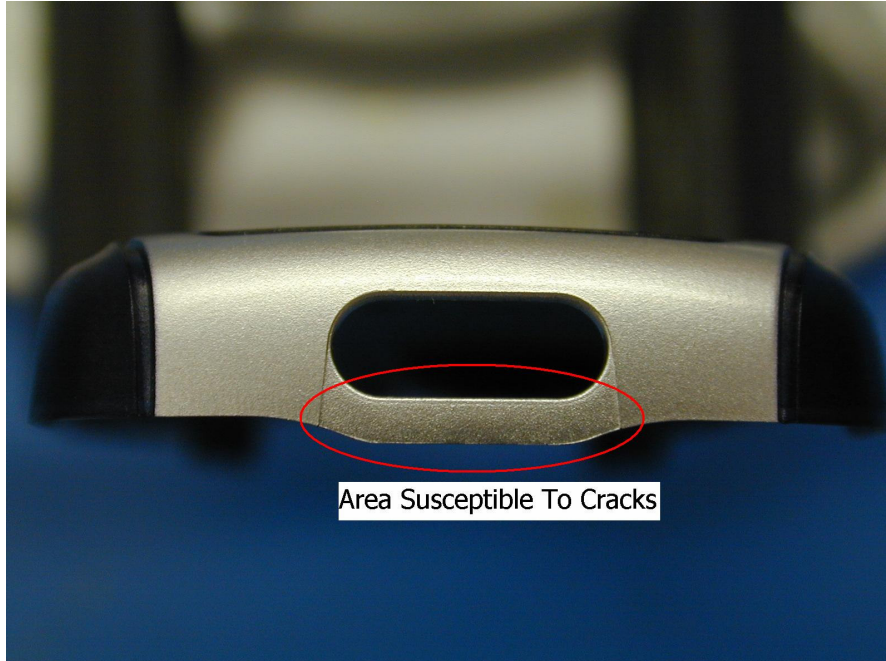
Service has been made aware of an issue with the C380 Rear Housing P/N's CFHN9029A (Blue) or CFHN9036A (Black). It is possible for the plastic housing to crack near the latch when installing or removing the rear housing. The plastic material used on the rear housing can become brittle, thus resulting in cracks. Refer to photo below:

The supplier has modified the housing molding process. The change consists of switching to a smaller barrel in the molding press where the material passes from solid to fluid. In doing this, the time that the material is at a hot temperature is reduced, resulting in less material degradation and improved mechanical performance. These process changes have taken place starting Sept 20, 2004.

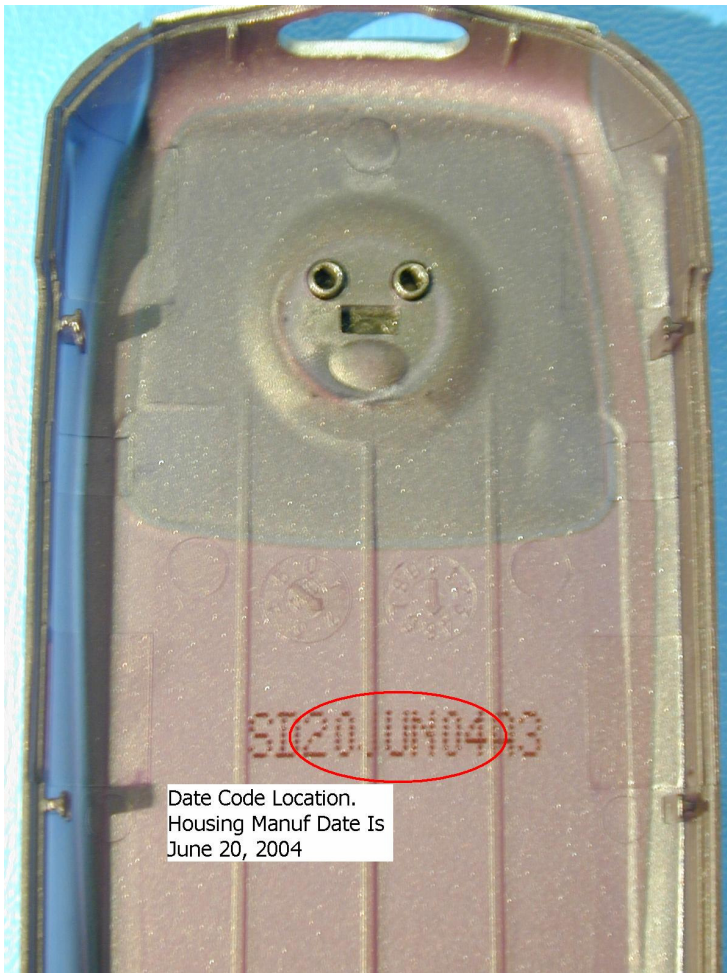
On all C380 units returned for service, remove the rear housing and verify the housing's date of manufacture. If the date code is prior to Sept 20, 2004, replace the rear housing with a date code of **Sept 20, 2004 or later**. The photo below shows the location of the rear housing's manufacturing date.
