**C550 Camera Bezel Dropping/Missing**

Our Reference: SI24\_3\_2004

Product/System: C550

Subject: **C550 Camera Bezel Dropping/Missing**

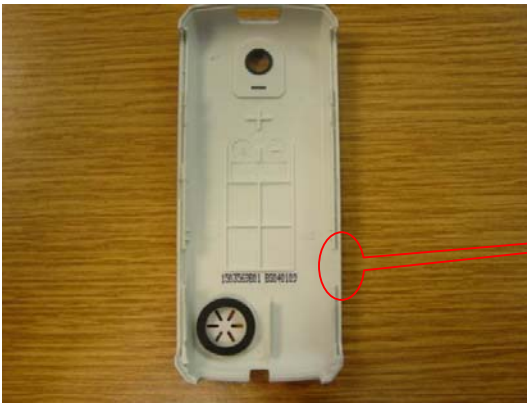
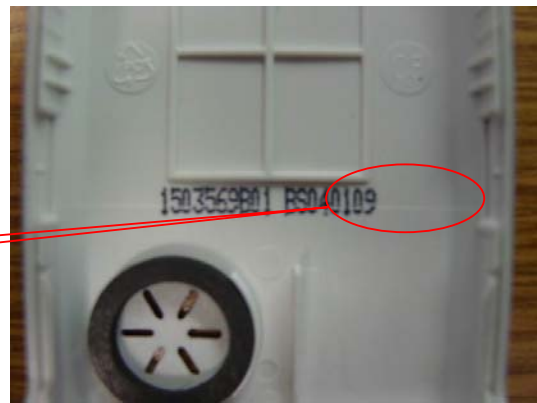
The issue was found in China. Customers complain C550 Camera Bezel Dropping/Missing from battery door.

The initial analysis show Camera Bezel hasn't enough adhesion. The supplier Banshing has change the process to get enough adhesion on Jan 9, 2004. But the bezel failed even after date code BS040109 (YYMMDD). Further analysis show the issue is generated by compression force of the gasket between the camera and the bezel.

In addition, due to focusing problem the tolerance on the camera height of the following Rev A camera module has changed from +/- 0.15 mm to +0.21/-0.15 mm. In this case, the forces against the bezel will increases a lot again.

The design team has decided to remove the gasket to avoid compression force. The design team is pursuing the re-design of new thinner gasket.
