***Field Service Information***

**C550 GSM Damaged Audio Filter U902**

Our Reference: SI29\_4\_2004

Product/System: C550

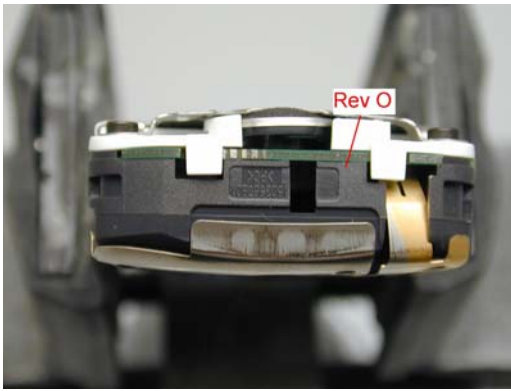
### Rev O Endo Plastic

Service has been made aware of an audio issue on C550 units. Insufficient clearance exists between the U902 Audio Filter which is mounted on the PCB and the endo plastic. As a result, it is possible for U902 to become sandwiched between the endo and the PCB during the assembly process and thus dislodging or damaging U902 as the assembler forces the PCB to fully seat in the rear endo. When this occurs, the unit will fail for no speaker/earpiece audio.

- 1) Check the version of the endo plastic on the unit. If it has the Rev O version, then proceed to Step 2. If the endo is a Rev A, then continue to process the returned unit per normal troubleshooting procedures. Refer to the two photos below to aid in distinguishing between the Rev O & Rev A versions:

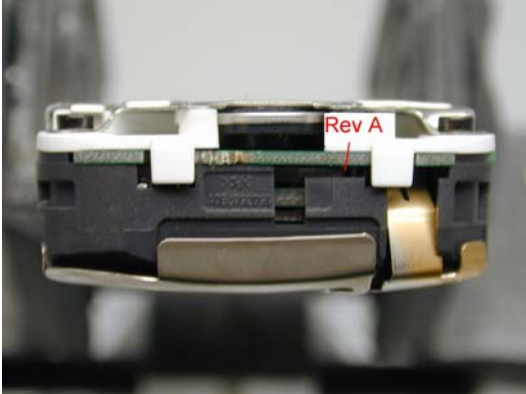
### Rev A Endo Plastic

The clearance problem has been resolved with a modification to the rear endo plastic- the length of the plastic tab near U902 has been reduced to allow for more clearance between these two components. This modified endo assy is P/N 0103560B01.

3) Reassemble the unit using endo assy 0103560B01.
