FIELD SERVICE BULLETIN

FSB Number: BJCCFSB2004-108
Author: Li Bin
Date: May 17, 2004
Total No. Of Pages: 3
Subject: **GSM C650 Update WI to check keypad assembly FSB**
Model Affected: C650 all model
Level of Repair: 1

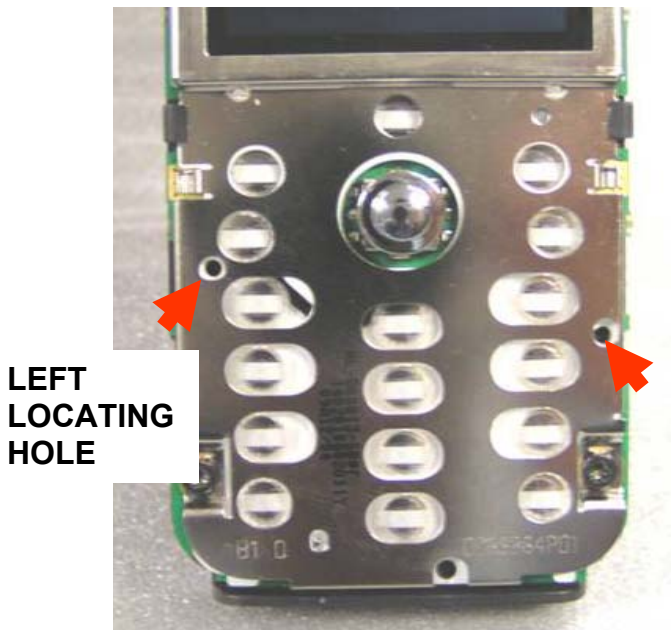
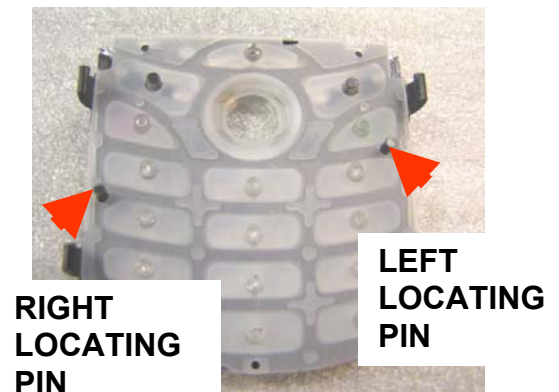
ENDO LOCATING HOLES & KEYPAD LOCATING PINS

Keypad locating pins must be aligned to the locating holes.

If the keypad no function and poor tactile returns, please check the keypad assembly first.
Reassembly the keypad can solve the complaints.

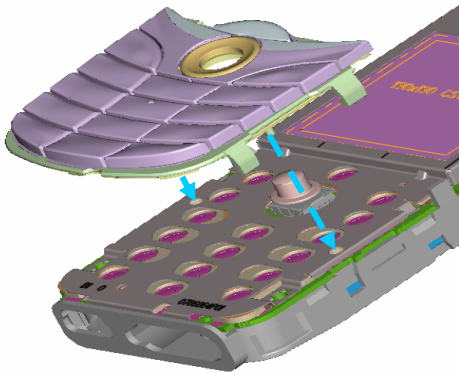
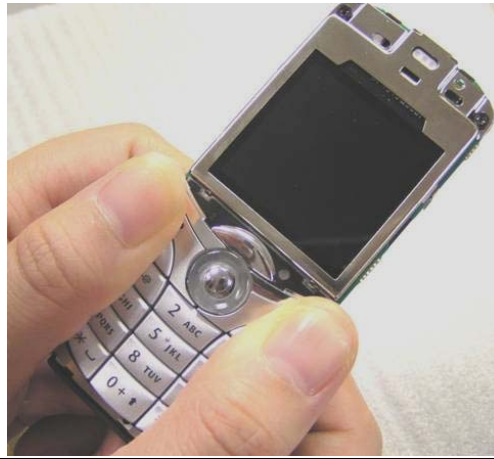
KEYPAD INSERTION

Keypad to be assembled as shown.

Use both thumbs to press on the keypad as shown.

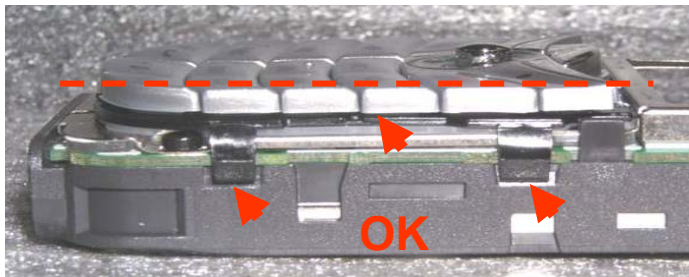
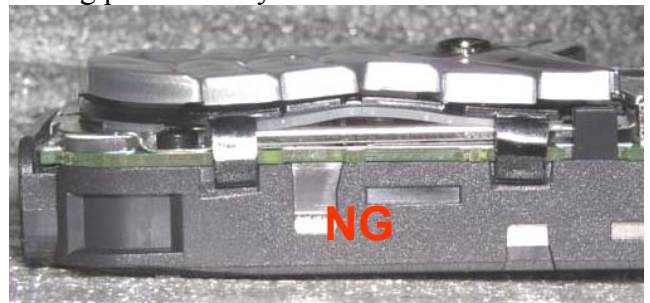
Right Side

Ensure all catches are snapped onto Endo properly and locating pins are fully seated as shown below.
