FIELD SERVICE BULLETIN

FSB Number: BJCCFSB2004-109
Author: Li Bin
Date: May 17, 2004
Total No. Of Pages: 2
Subject: **GSM C650 rear housing hard open issue**
Model Affected: C650 all model
Level of Repair: 1

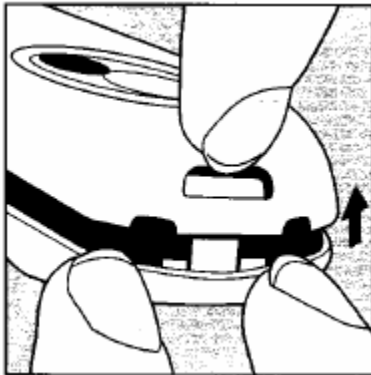
GSM C650 "rear housing hard open" issue was found during user trial in all regions. Customers complain rear housing hard to open => compromise had to be found between proper fit with small gaps and force required to open. A number of units were found the same issue but not counted as the 1st 200 NPI units.

3 fingers open - illustration is needed to instruct end user how to open.

If the hard open rear housing returns, please instruct user as above picture show how to open.
