FIELD SERVICE BULLETIN

FSB Number: LVCCFSB2004-128
Author: Max Dekirmandjian
Date: June 9, 2004
Total No. of Pages: 2
Subject: C650 No Camera Function
Model Affected: C650
Level of Repair: 2

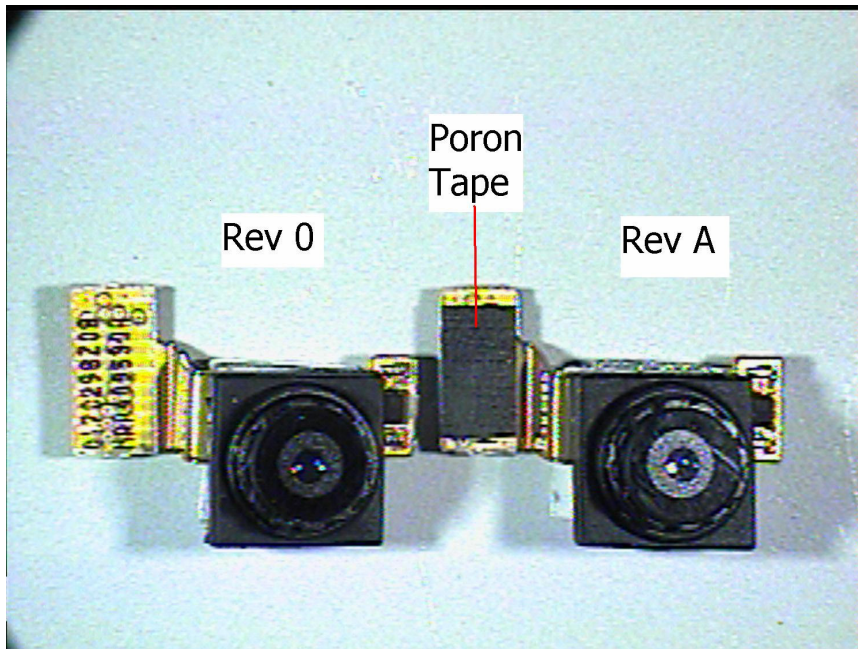
Service has been made aware of a camera issue on the C650 product. The camera module to PCB connector at times will not mate properly, resulting in an intermittent or no camera operation when attempting to capture a photo.

1) A poron tape has been added to the top of the module to PCB connector.
Refer to the photo below to aid in distinguishing between the Rev 0 and Rev A camera modules:

A redesigned camera module has been implemented in production units. The part number 0170298Z08 changes from a Rev 0 to Rev A. This Rev A module has two modifications from the original design:

- 1) Disassemble the unit to gain access to the camera module;
- 2) Verify that the module has the poron tape installed on the camera flex as shown in the above photo. Replace with a Rev A module if necessary.
- 3) Reassemble the unit and test camera operation.

Purge Camera Module 0170298Z08 Rev 0 and restock with Rev A.
