FIELD SERVICE BULLETIN

FSB Number: LVCCFSB2004-230
Author: Max Dekirmandjian
Date: November 23, 2004
Total No. of Pages: 3
Subject: C380/C650 Display-ITO Corrosion & Misaligned Flex
Model Affected: C380, C381P, C650, C651 GSM
Level of Repair: 2

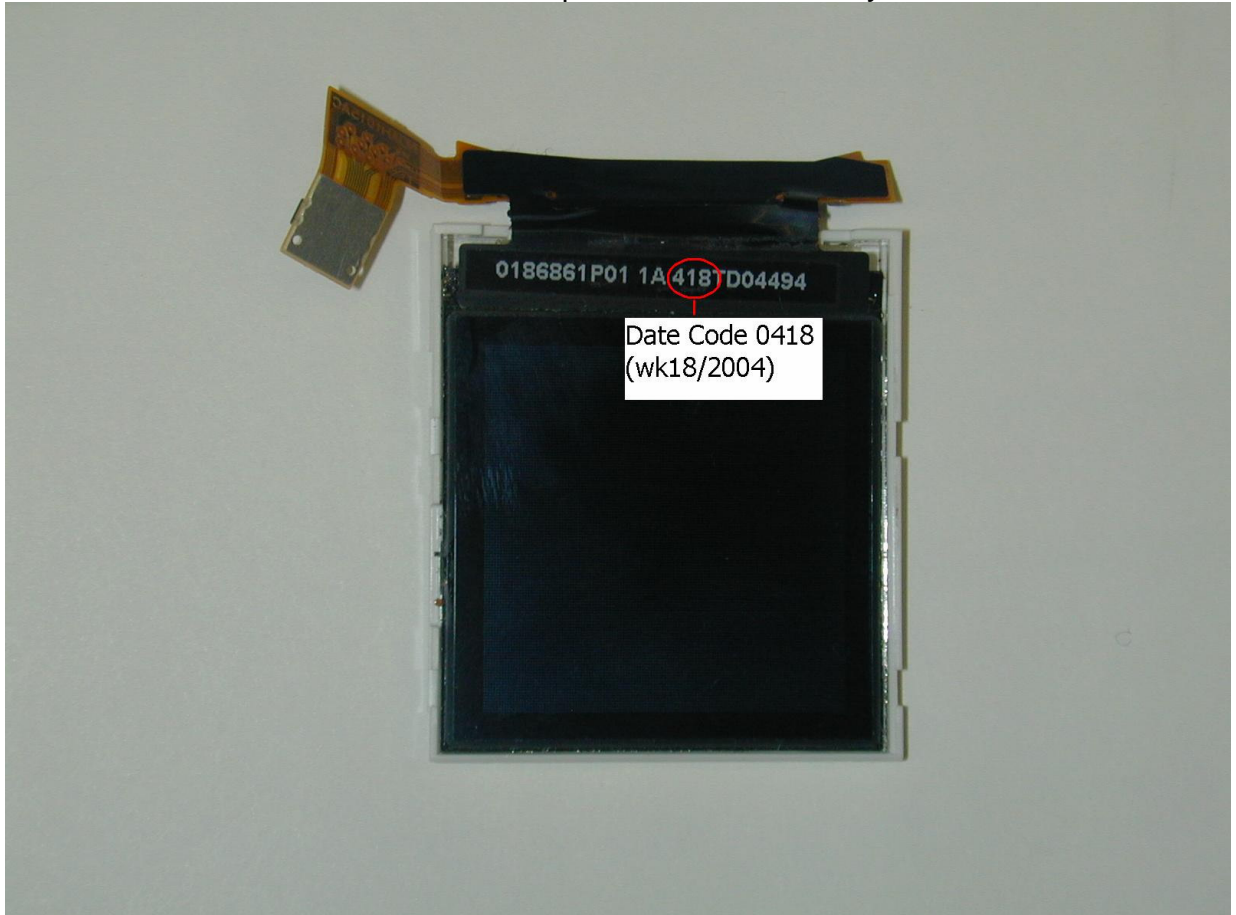
- 1) Disassemble the unit to gain access to the display module.
- 2) Check the date code on the display module. The photo below shows the location of the date code. The example shown is wk18 of year 2004.

- 3) If the date code is 0427 or earlier, replace the display module with date code 0428 or later.
- 4) Re-assemble the unit and verify the display is now functional.
