FIELD SERVICE BULLETIN

FSB Number: LVCCFSB2005-115
Author: Max Dekirmandjian
Date: April 14, 2005
Total No. of Pages: 2
Subject: C650 & V220 No Charge-Q901 & F900 Open
Model Affected: GSM C380, C381, C381P, C650, C651, V180, V188, V220, V226
Level of Repair: 2

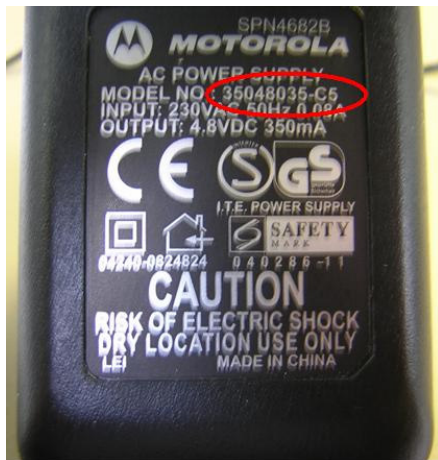
C650 & V220 customer units are being returned with complaints of “Unable To Charge” or “No Charge”. Development has traced the root cause to a non-conforming charger manufactured by Leader Elections Inc. (LEI), China. The LEI charger does not have a bleeder resistor, making it unregulated and susceptible to spikes in the line voltage, which can lead to excessive charging current-damaging Q901 and blowing F900.

- 1) Verify that the charger accompanied with the unit is LEI. LEI chargers have the supplier model number 35048035-A1/A2/C5 printed on the charger's label. If the charger is not LEI, proceed to troubleshoot the unit per normal servicing procedures. Refer to the photo below to aid in identifying a LEI charger:

- 2) Disassemble the unit to gain access to Q901 & F900.
- 3) Visually inspect Q901 for damage. Replace if necessary.
- 4) If no damage is evident, measure the resistance of the Q901 collector-emitter junction. Replace if the junction is shorted (approx 1 ohm or less). A known good unit can be used for comparison purposes.
- 5) Measure the resistance of F900. Replace if open.
- 6) Reassemble the unit
- 7) Connect either a Phihong or Salom charger to the unit and verify proper charger operation.
- 8) Scrap the LEI charger and replace with either Phihong or Salom.
