FIELD SERVICE BULLETIN

FSB Number: LVCCFSB2005-297
Author: Max Dekirmandjian
Date: September 15, 2005

Subject: C65x GSM Turn On In Flash Mode Informational Bulletin

Model Affected: C650, C651 GSM

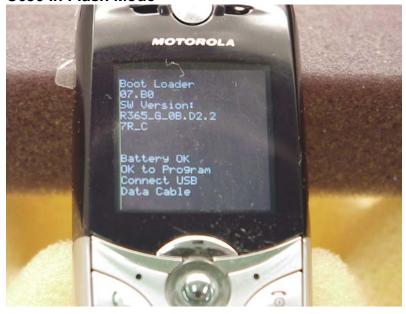
This is an informational bulletin to notify Service of a turn on condition which can occur with C650 & C651 units. If the <Power>, <#3>, and <Right Soft Key> are pressed simultaneously while attempting turn on, the unit may power up in flash mode. If this happens, the phone's battery must be removed in order to restart the unit. The photo below shows what appears on the phone's display when in flash mode:

C650 In Flash Mode

Educate the consumer and service shops to depress only the <Power> key when attempting unit turn on.

When responding to inquiries related to C65x Turn On, determine if the customer's unit is powering up in flash mode. If yes, inform customer that this condition can occur if the <Power>, <#3>, and <Right Soft Key> are pressed simultaneously. Instruct customer to attempt turn on by removing and reinstalling the phone's battery, and then depressing the <Power> key only.
