# Field Service Information C650 No Camera Function

Our Reference: SI33 6 2004

Product/System: C650

Subject: C650 No Camera Function

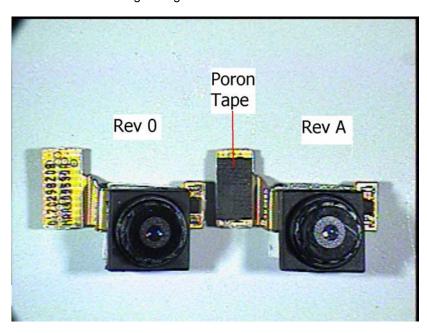
Service has been made aware of a camera issue on the C650 product. The camera module to PCB connector at times will not mate properly, resulting in an intermittent or no camera operation when attempting to capture a photo.

1) A poron tape has been added to the top of the module to PCB connector. Refer to the photo below to aid in distinguishing between the Rev 0 and Rev A camera modules:

A redesigned camera module has been implemented in production units. The part number 0170298Z08 changes from a Rev 0 to Rev A. This Rev A module has two modifications from the original design:

- 1) Disassemble the unit to gain access to the camera module;
- 2) Verify that the module has the poron tape installed on the camera flex as shown in the above photo. Replace with a Rev A module if necessary.
- 3) Reassemble the unit and test camera operation.
