Field Service Information

GSM C650 – J931 connector detached.

Our Reference: SI39_8_2004

Product/System: GSM C650

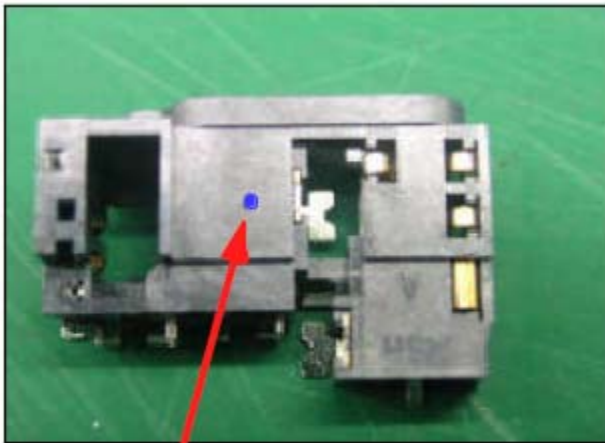
During MOL analysis of a C650 GSM product, service discovered some instances of the assembly J931 connector being completely detached from the board causing intermittent or no contact to the PCB. The problem arises from the solder tail co-planarity issue of Molex 3-in-1 connector causing poor solder connection between pad and solder tail tab during reflow.

Molex has concluded the analysis and improved their housing and tail forming design to prevent the solder tail bending issue. Molex started cross over of their production to the new housing and connector design, starting week 28. The new connector housing is marked with one blue dot (0970312J01). See photo below for illustration.

Blue dot is on the housing

- 1) Disassemble the Housing Assembly and verify that the connector J931 (0970312J01) is detached from the PCB. Replace with a new connector that has the blue dot on the housing.
- 2) If the connector is intact, then proceed with normal troubleshooting techniques per customer complaint.
