Field Service Information

GSM C650 polyphonic speaker defect

Our Reference: SI43_9_2004

Product/System: C650

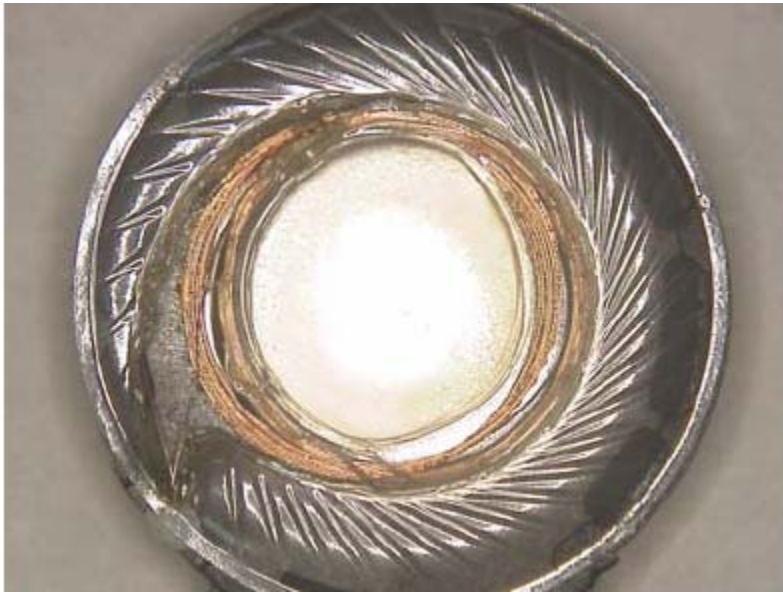
GSM C650 polyphonic defect issue was found when product post-launch NPI analysis (May 2004) and affect all regions. Service has been made aware of the issue. 3 major failure modes identified:

1. Voice coil scramble,
2. Diaphragm melting
3. Break of coil wire

Solution Supplier Citizen has presented the actions for heat resistance upgrade evaluation.

- Improvement at the coil wire's insulation film & bonding film
- Improvement for bonding glue between diaphragm & coil.
- Improvement plan to the wire material – with silver content above 2%.

If the polyphonic speaker is determined to be faulty, replace the speaker with date code wk 36 or later. Printed on the speaker surface you may see the date code 436
