FIELD SERVICE BULLETIN

FSB Number: LVCCFSB2005-110 (Revision A)
Author: Amador Hassell
Date: October 7th, 2005
Total No. of Pages: 3
Subject: **3G C980 / C975 / E1000 Microphone – Lo / Low Audio**
Model Affected: 3G C980, C975 and E1000
Level of Repair: 2

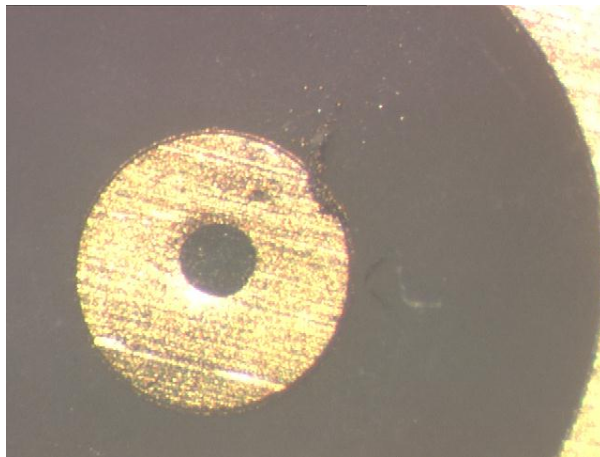
Service is aware that some C980 / C975 / E1000 units have been returned with "Microphone – No/Low Audio complaints" or "Noisy audio complaints". Unit analysis revealed foreign material contamination on the main board around the microphone contacts. The presence of debris in this area causes intermittent connection with the microphone assembly and, in some instance, blocks completely the signal from the transducer. Due to intermittent contact between the Mic and the PCB the user and the called party will experience crackling noise. This is attributed to sidetone audio (Routing of the microphone audio back to the speaker so the user can "hear" what they are speaking).

Contaminated microphone contacts

The transducer's signal is blocked due to the presence of foreign material between the elastomeric connector and the PCB's pads. At this point, no design solutions are scheduled and the Service Centers are instructed to ensure cleanliness in the microphone contacts area to prevent signal loss.
