## **FIELD SERVICE BULLETIN**

FSB Number: LVCCFSB2005-167  
Author: Max Dekirmandjian  
Date: May 23, 2005  
Total No. of Pages: 3  
Subject: E398 MFT Distortion  
Model Affected: E398 GSM  
Level of Repair: 2

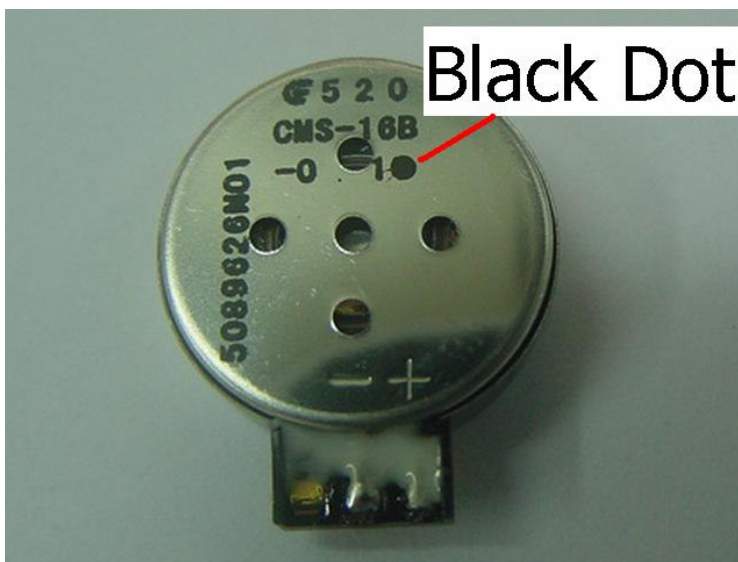
- 1) Disassemble the unit to obtain access to the Chassis Speaker Assembly. Refer to the Level 1 & 2 Service Manual for proper disassembly instructions.
- 2) Verify that each MFT is date code 0520 or later by observing a black dot on each MFT. The photo below shows the location of the black dot.

Note: Ensure that **both** MFT's on the Chassis Speaker Assembly have a black dot.

- 3) If no black dot is present on either MFT, replace the Chassis Speaker Assembly with a new assembly that contains MFT's date code 0520 or later.
- 4) If both the MFT's in the returned unit are date code 0520 or later, proceed to troubleshoot the unit per normal service procedures.
