FIELD SERVICE BULLETIN

FSB Number: LVCCFSB2004-255
Author: Max Dekirmandjian
Date: December 16, 2004

Subject: E398-Loose Power/End Key

Model Affected: E398 GSM

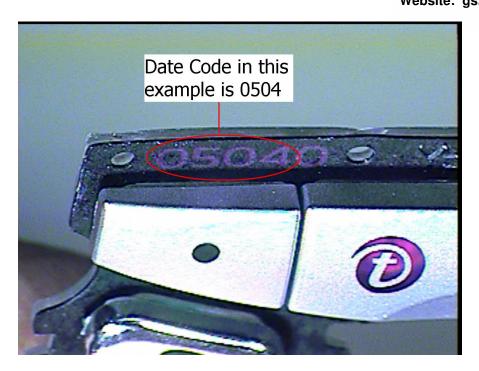
Analysis of keypad related complaints from the 1st 200 E398 NPI returns has revealed that the cap on the Power/End key is becoming loose and detaching from it's base. This is due to instability of the primer used during the manufacturing process, thus contributing to poor bonding strength of the adhesive. This occurred on both 3 and 4-key keypads.

The date code is located in the upper left corner near the left soft key. Refer to the photo below to assist in Keypad date code identification.

Replace the Keypad with date code of 0604 or later on E398 returns that have complaints such as:

Purge all 3 and 4-key E398 keypads with date code 0504 or earlier.
