FIELD SERVICE BULLETIN

FSB Number: LVCCFSB2004-259
Author: Max Dekirmandjian
Date: December 21, 2004
Total No. of Pages: 3
Subject: E398-No or Distorted Earpiece Audio
Model Affected: E398 GSM
Level of Repair: 2

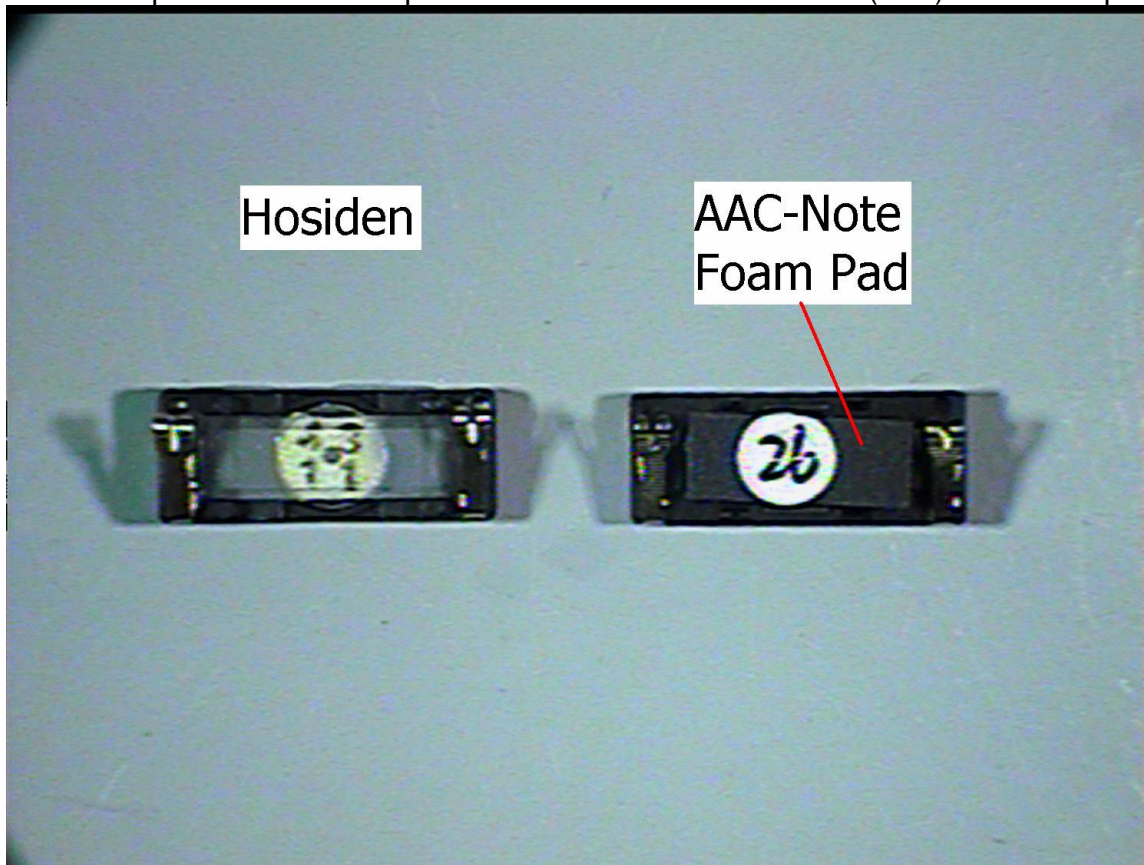
- 2) Observe the contact side of the Earpiece to determine if the manufacturer is Hosiden. The photo below shows Hosiden vs AAC Earpiece. Notice that the AAC Earpiece has a foam pad attached to the contact side (rear) of the component.

- 3) If the manufacturer is confirmed to be Hosiden, replace the Earpiece with AAC.
Note: Do not remove the foam pad from the AAC Earpiece. The foam pad remains attached to the earpiece.
- 4) Reassemble the unit and verify that earpiece audio is now functional.
