FIELD SERVICE BULLETIN

FSB Number: LVCCFSB2005-311
Author: Max Dekirmandjian
Date: October 11, 2005
Total No. of Pages: 4
Subject: E398 GSM 256 MB TransFlash Card No Detect
Model Affected: E398 GSM
Level of Repair: 3

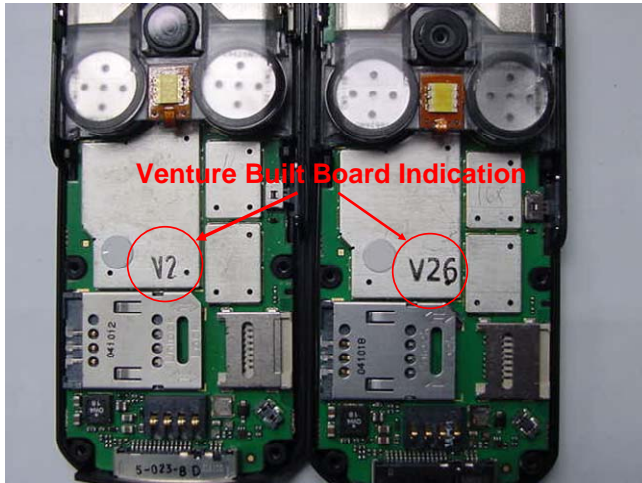
- 1) Insert a known good 256MB Transflash card in the unit;
- 2) Power on the unit;
- 3) Attempt to read the Transflash card thru the phone's menu-Settings>Phone Status>Storage Devices>Details. A readable card will display it's memory contents. If the card is not readable, proceed to Step 4;
- 4) Remove the rear housing to access the PCB RF shields;
- 5) Verify that the PCB is manufactured by Venture by observing the "V" stamp on the RF shield. Photo #1 shows two examples of Venture-built PCB's:

Photo #1: Examples Of Venture Built PCB's

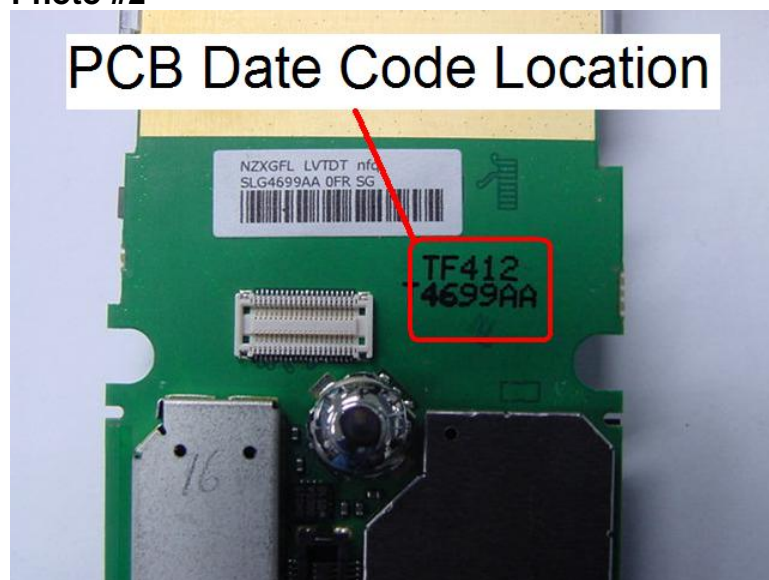
- 6) If the PCB is determined to be manufactured by Venture, remove the PCB from the front housing;
- 7) Remove the display module from the PCB;
- 8) Note the PCB date code stamped near the display module connector. If the date codes are TF405 thru TF421, then proceed to Step 9. Refer to Photo #2 to aid in identifying the PCB date code location:

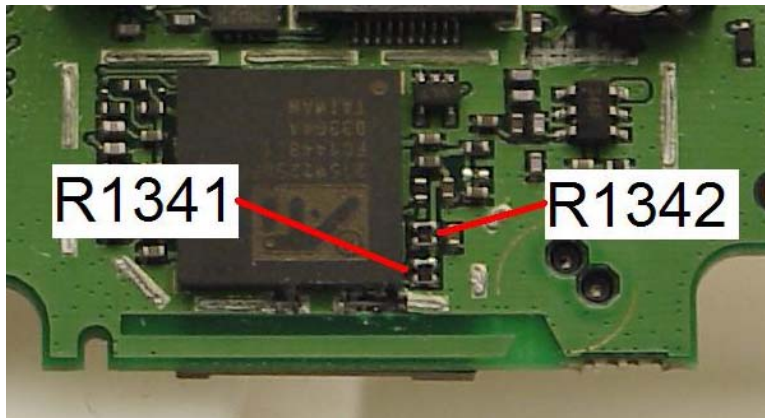
Photo #4

Service is aware of an issue with the E398 GSM phone when used with a TransFlash card. The unit is not able to recognize a 256MB memory card. No problems were reported with the 64 or 128MB card. The root cause is due to two resistors on the PCB, R1341 & R1342 having the orientation misplaced by 90 deg. These PCB's were manufactured by supplier Venture in April 2005. 37K units are affected.

10) Inspect R1341 & R1342 for proper orientation as shown in Photo #4. If in doubt, compare the orientation to a known good board. Reposition if necessary;
