Field Service Information

E398-No or Distorted Earpiece Audio

Our Reference: SI70_12_2004

Product/System: **E398**

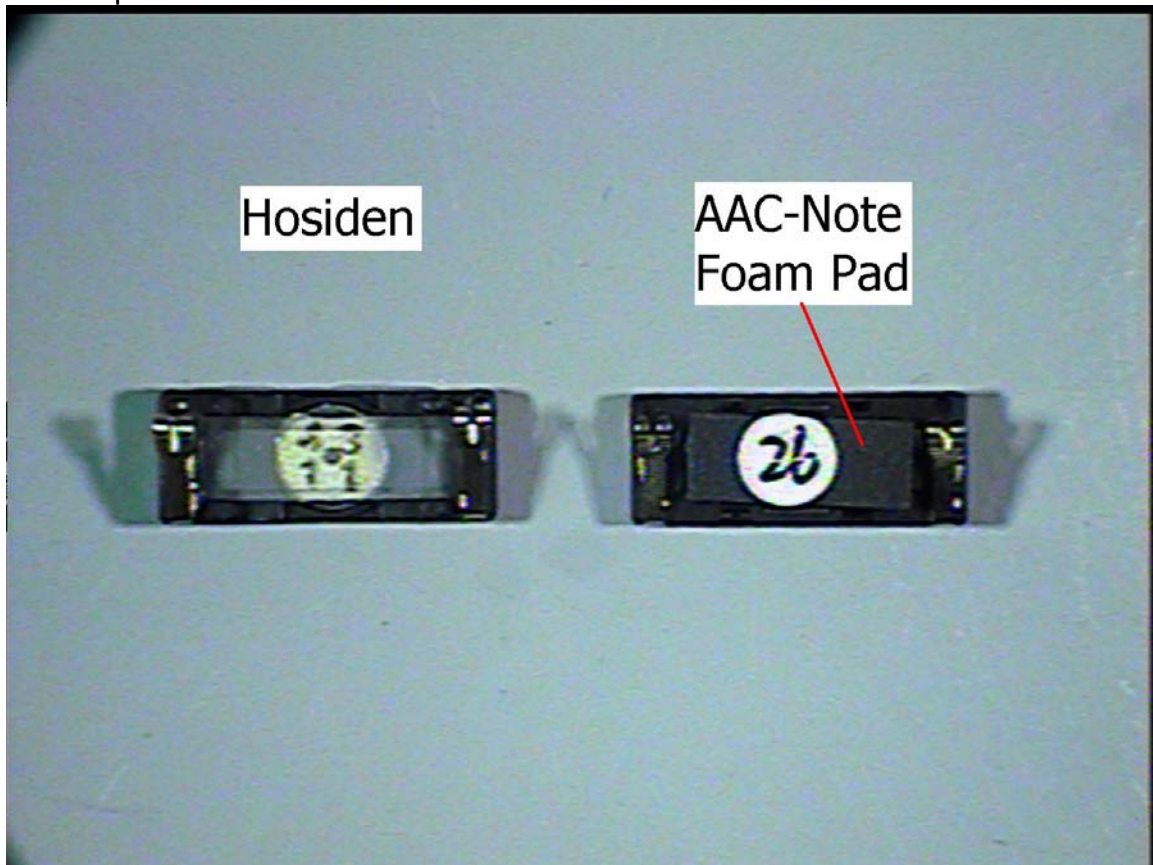
Analysis of audio-related failures on the 1st 200 E398 NPI returns has revealed inoperative or distorted Earpiece speakers, manufactured by Hosiden Electronics. The causes of these failures are a result of any one of the following:

- 1) Overheated voice coil which resulted in damage to the diaphragm
- 2) Voice coil winding deformed/slanted
- 3) Voice coil winding split
- 4) Insufficient bonding of coil windings

- 2) Observe the contact side of the Earpiece to determine if the manufacturer is Hosiden. The photo below shows Hosiden vs AAC Earpiece. Notice that the AAC Earpiece has a foam pad attached to the contact side (rear) of the component.

- 3) If the manufacturer is confirmed to be Hosiden, replace the Earpiece with AAC.
Note: Do not remove the foam pad from the AAC Earpiece. The foam pad remains attached to the earpiece.
- 4) Reassemble the unit and verify that earpiece audio is now functional.
