CSB-1190-3
 Country : UK
 Date : 2/2/2007
 APC : G26
 Repair Level : 3

Title M702iGM702iSMOTORAZR V3xx - 3G - Atlas_Switcher
 Model Effected Izar_Japan, Izar_Global, Izar_Global i-mode and Scorpius

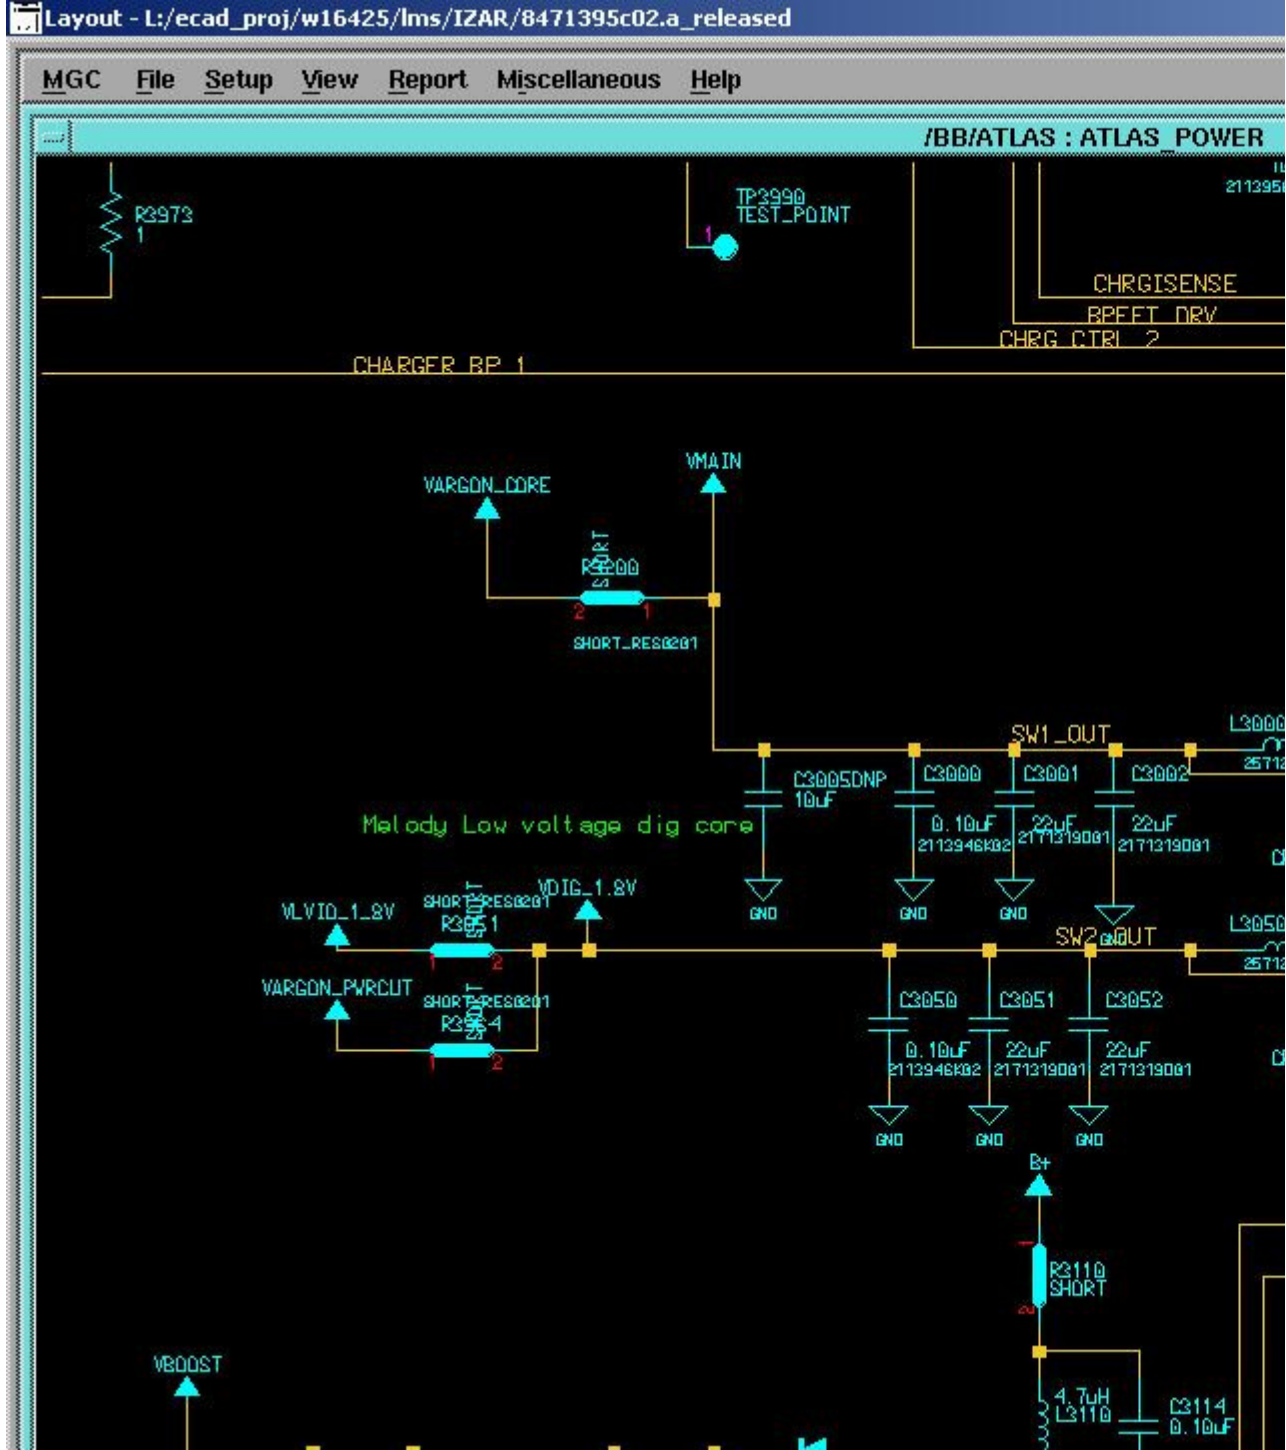
Switcher LX pins in schematic

- 1. Confirm phone panics with white screen after it goes into DSM.
- 2. Confirm phone does not panic when USB cable is plugged in.
- 3. Monitor switcher LX pins to confirm SW1 or SW2 or both fail in PFM mode, and record Atlas date code.
- 4. Determine if the device is functional or if it needs to be replaced.

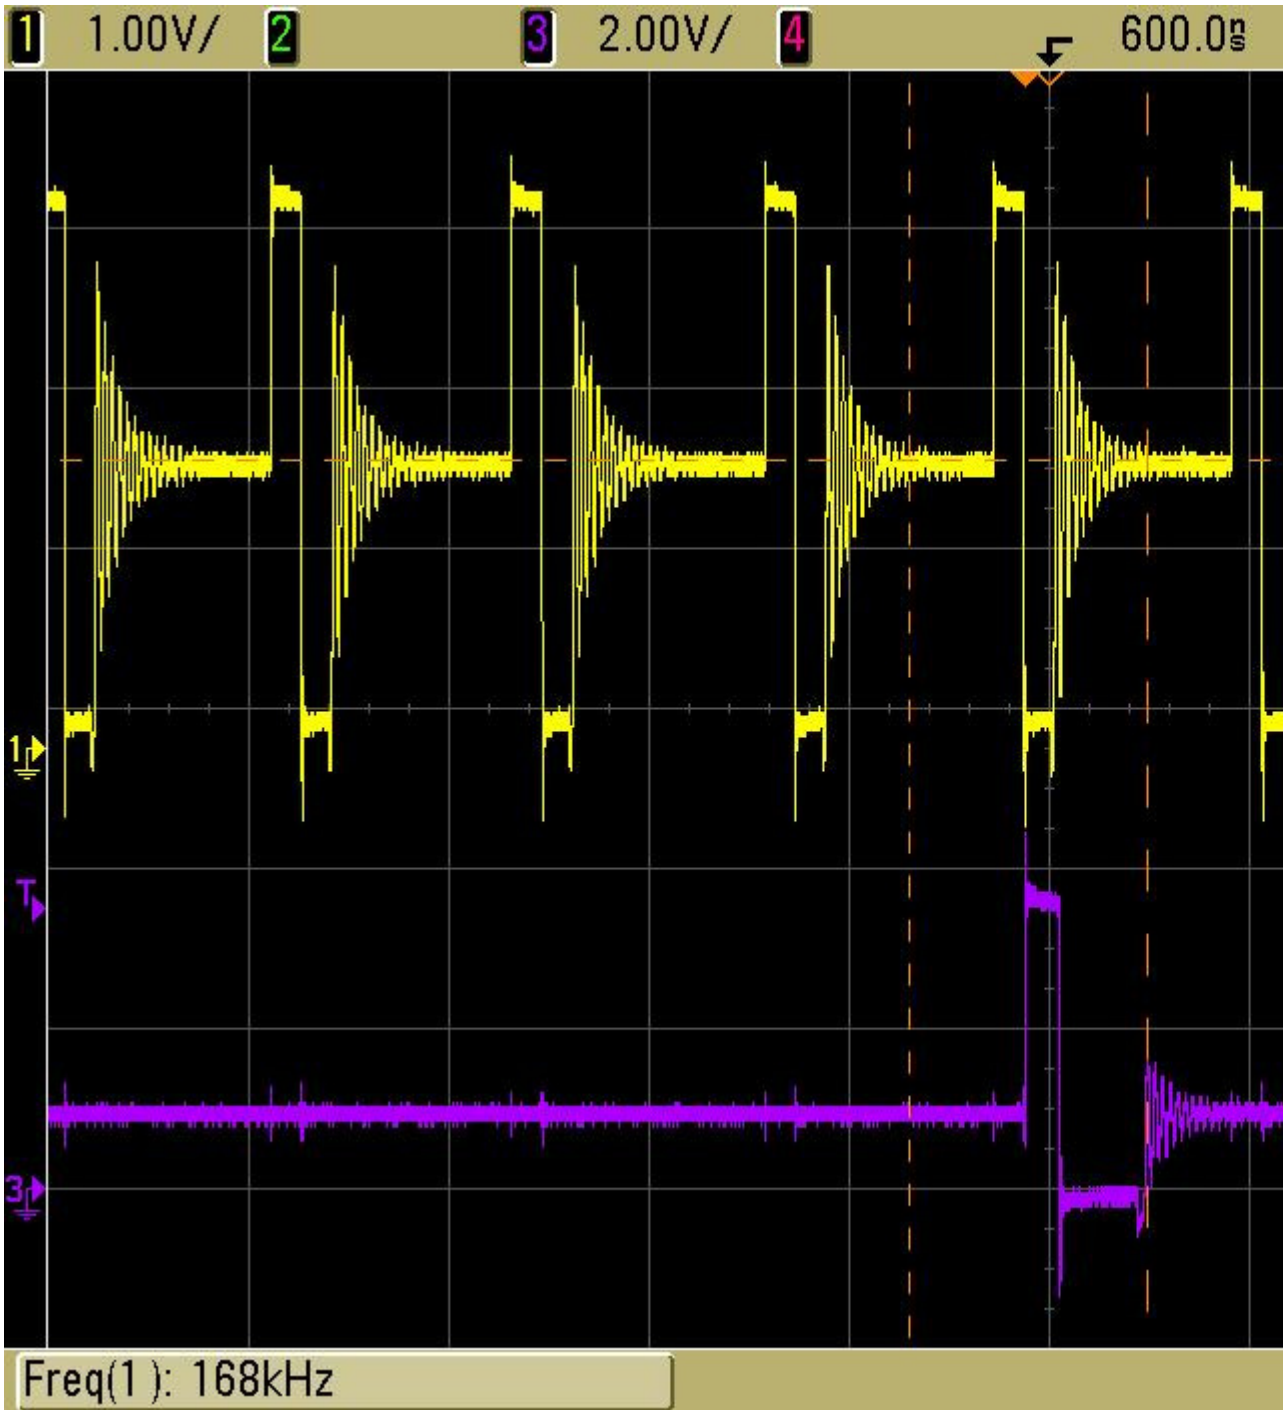
Good Unit

Channel 1: SW1 LX

Channel 2: SW2 LX

When phone goes into DSM, Atlas SW1 and SW2 LX pin switches normally at KHz range in PFM mode.

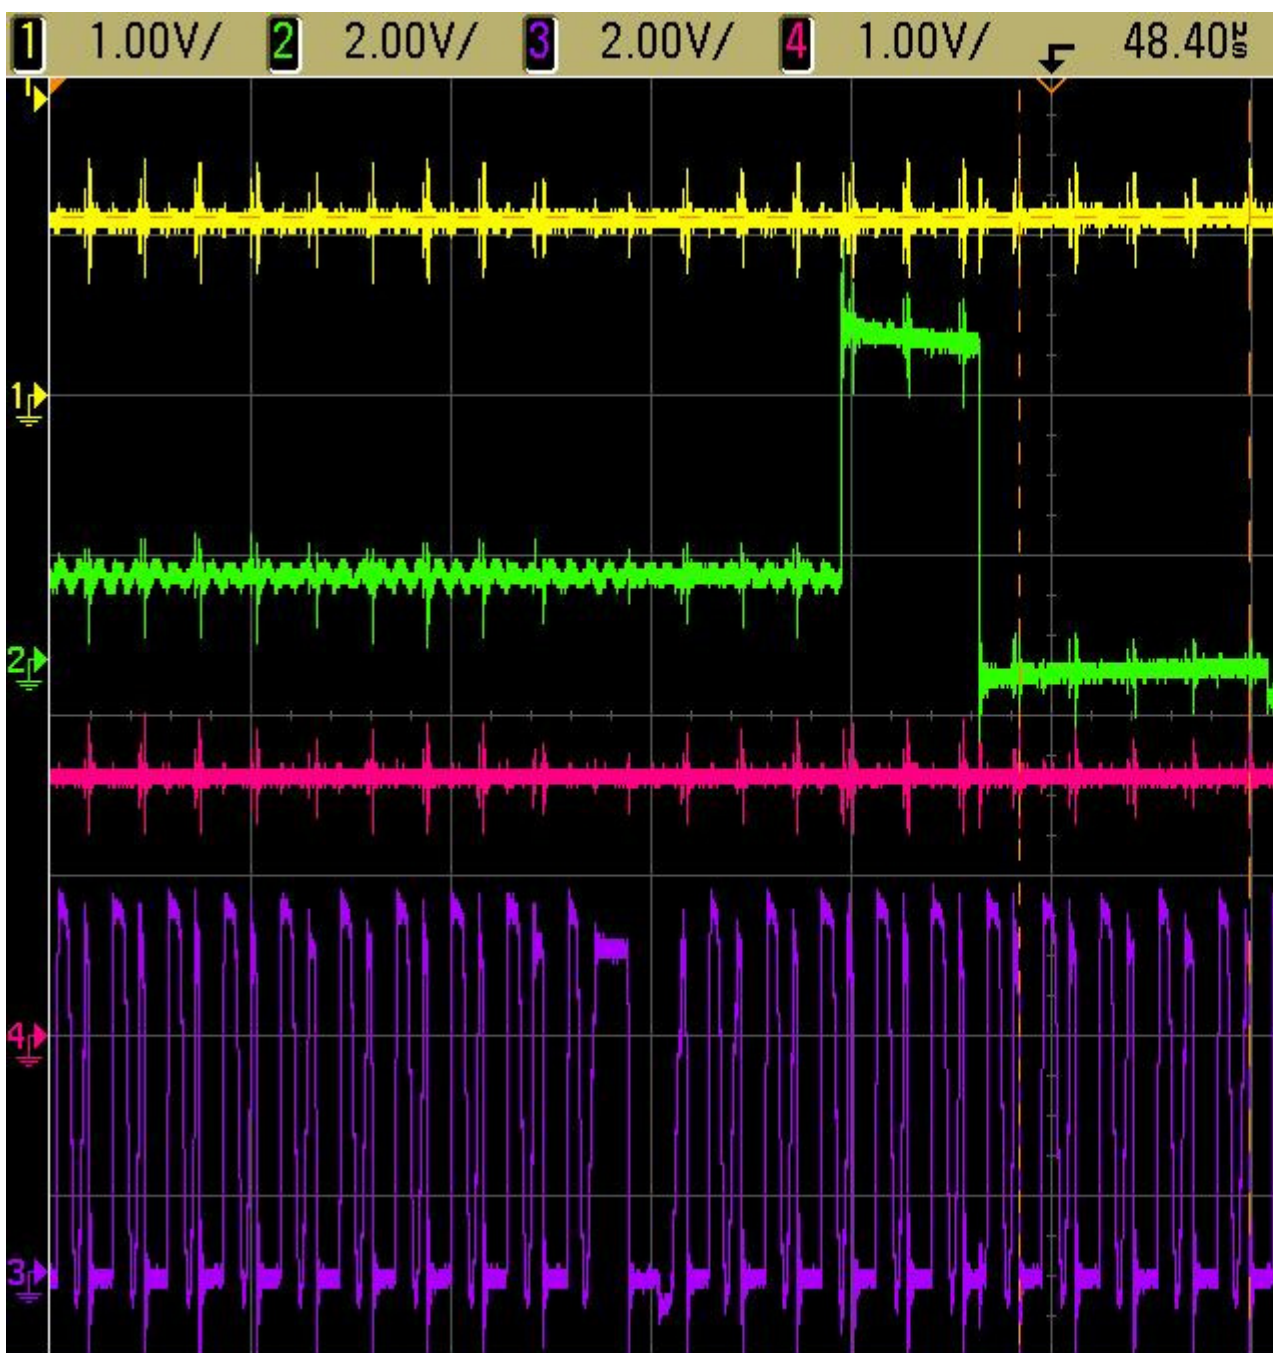
Bad Unit

Channel 1: SW1 output

Channel 2: SW1 LX

Channel 3: SW2 LX

Channel 4: SW2 output

When phone goes into DSM, Atlas SW1 LX pin switches normally at KHz range and SW2 LX pin switches abnormally at MH PFM mode.
