FIELD SERVICE BULLETIN

FSB Number LVCCFSB2007 - 81
Author Anthony Bryan
Date Monday, March 05, 2007
Subject **GSM - MOTOKRZR K1 - Board to Board Connector (Compatibility)**
Model Affected GSM KRZR K1
Level Of Repairs 2

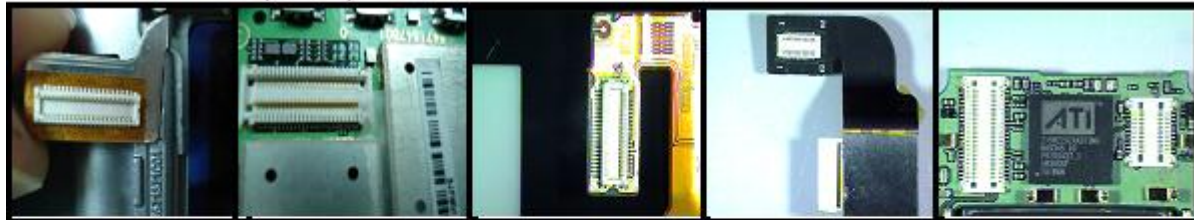
Molex Connectors (White)

Service is aware of a component hardware compatibility issue that affects certain production models of GSM KRZR K1. After initial product ramp, Foxlink was brought up as a second source supplier for the board to board connectors used on the KRZR K1 product. The new Foxlink connectors are not compatible with the existing connectors supplied by Molex. Attempting to mate connectors that are miss-matched from each supplier will result in structural damage to the connectors. This change was managed in production by re-structuring the BOM and creating new part numbers to support both connector suppliers. The connector supplier can be determined visually by the color of the connector. Molex connectors are white and Foxlink connectors are black. See Images and Part Numbers below. The phone model number was also up suffixed to SJUGxxxxDA to reflect the new hardware.

Service Teams should use the images above to determine the connector supplier and replace only with the corresponding part number for that supplier. See matrix below.

1. Visually inspect the original connectors to determine the supplier.
2. Replace using only the corresponding part number for that supplier.
