## **FIELD SERVICE BULLETIN**

FSB Number: LVCCFSB2004-112  
Authors: Darwin Garcia  
Date: May 19, 2004  
Total No. of Pages: 7  
Subject: **MPX200 Incomplete Software Upgrade**  
Model Affected: **MPX200**  
Level of Repair: 2

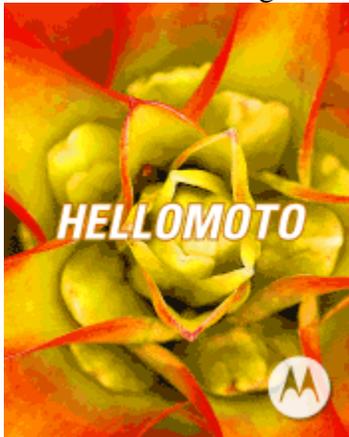
During a 21K MPX200 reflash project, service detected a problem in MPX200 GSM units that were not completely flash when using Upgrade Center 3.1. Affected phones will not turn on completely, depending of the percentage of the flash completed, most will hang on the HELLOMOTO screen, others might turn on but will not operate and in few cases not turning on. The battery will need to be removed to turn off the phone.

Customer phones that hang on the HELLOMOTO screen or does not operates will need to re-flash completely again. When utilizing Upgrade Center 3.1 with multi-flash stations operators should manually match the fixture's numbers with the port's label of the hub, label the USB cables accordingly, use fully charge batteries, and test all ports before major reflash projects.

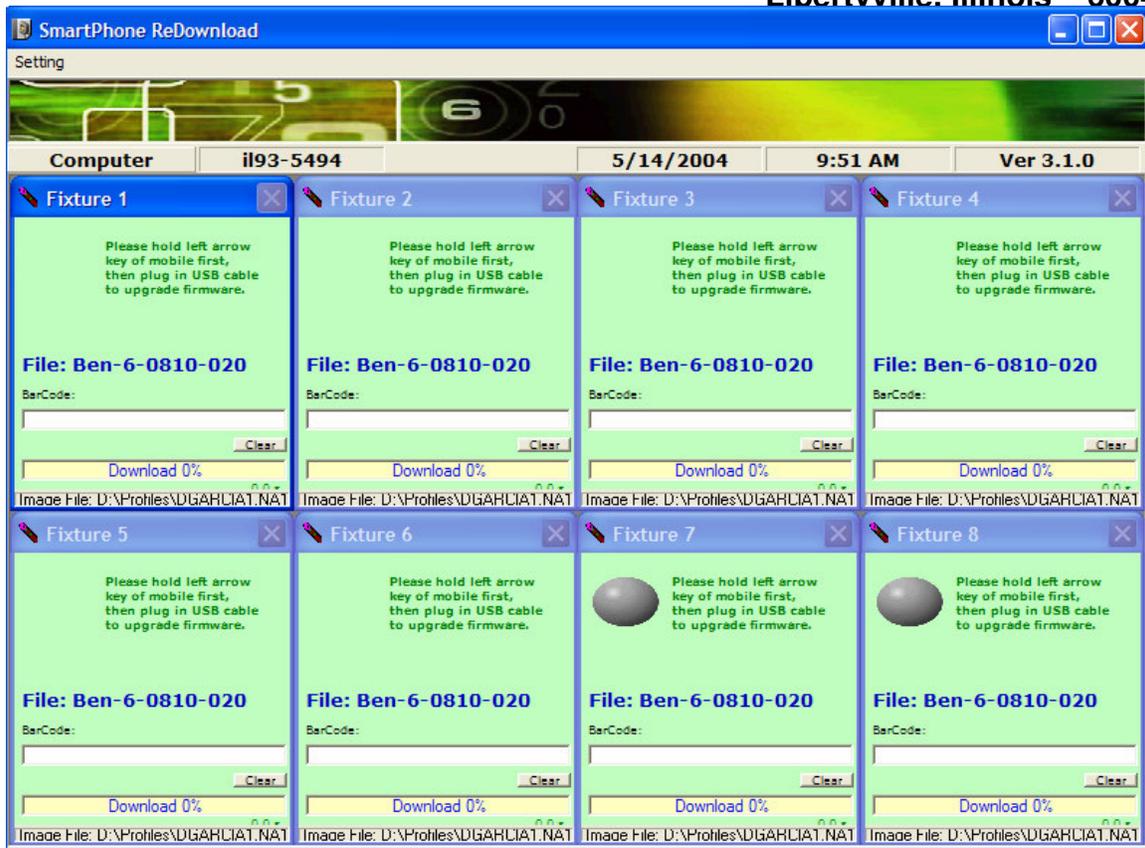
One of the causes of the problem is operator misunderstanding the fixture numbering sequence of the Upgrade Center 3.1 tool versus the physical number on the ports of the USB hub when utilizing a multi-flash station, which leads to inadvertently disconnecting the wrong phone before the software upgrade finishes. The numbers on the tool's fixture will not automatically match the physical label on the ports of the USB hub because the PC determines the internal COM port allocations base on ports activated and its capabilities. The upgrade center tool will select the order base of the PC systems port allocation, which makes keeping track of the ports alignment confusing during a major reflash project. Other possibilities are low battery, damage USB cables, USB hub ports freezing, PC system software/hardware failures, and Upgrade Center 3.1 software failures.

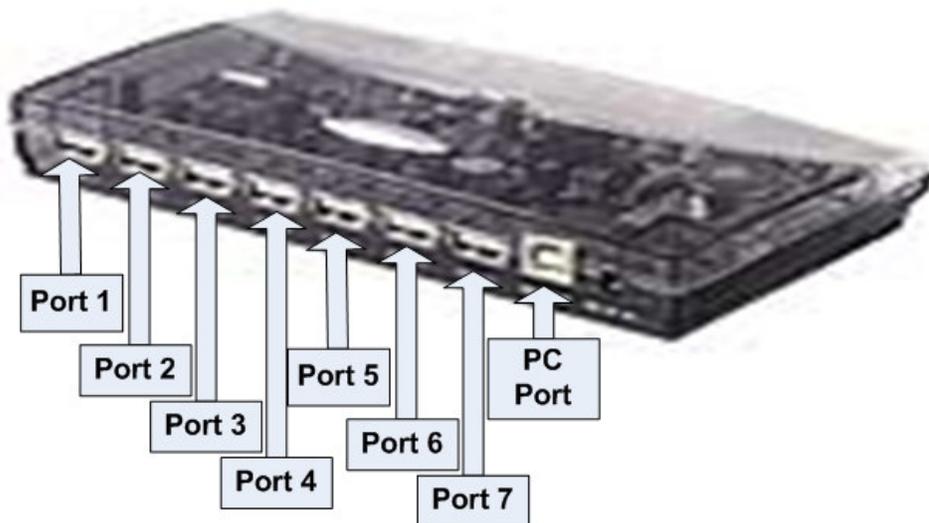
The fixture's numbers will not automatically match with physical port's labels of the hub.

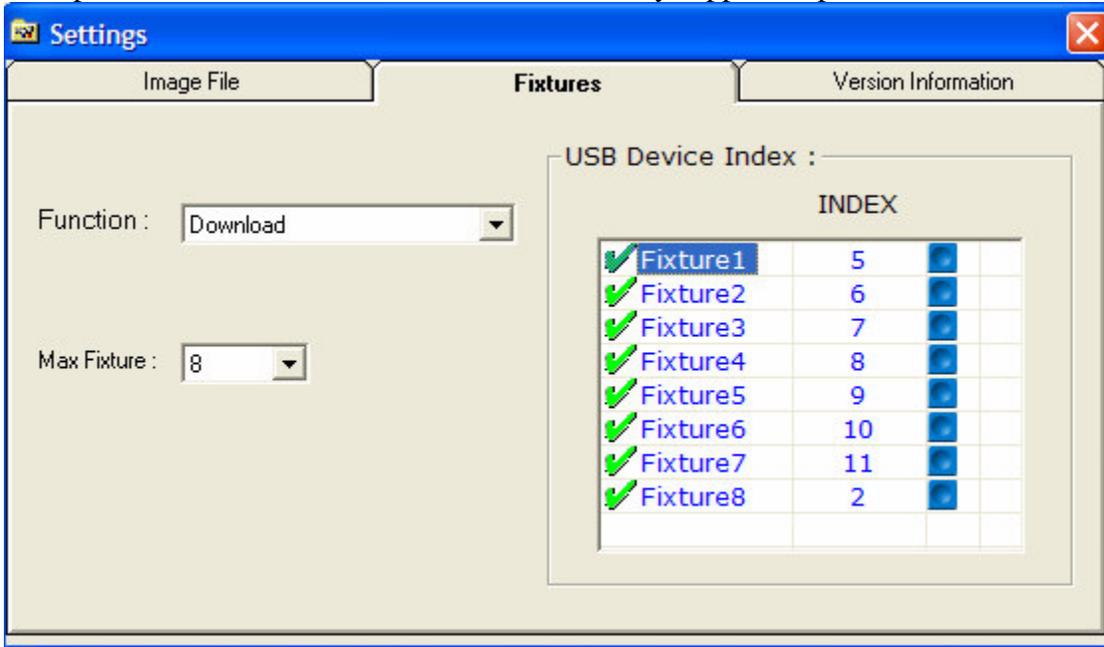
7. After all the ports are linked the index number of each fixture should align to each USB ports of the hub. In this case the USB hub only supports 7 ports.

6. Select the fixtures tab to manually match each fixture to a physical USB port. Click on the blue bottom for each fixture and link it to the USB ports in the desire order, use the COM numbering for guidance.

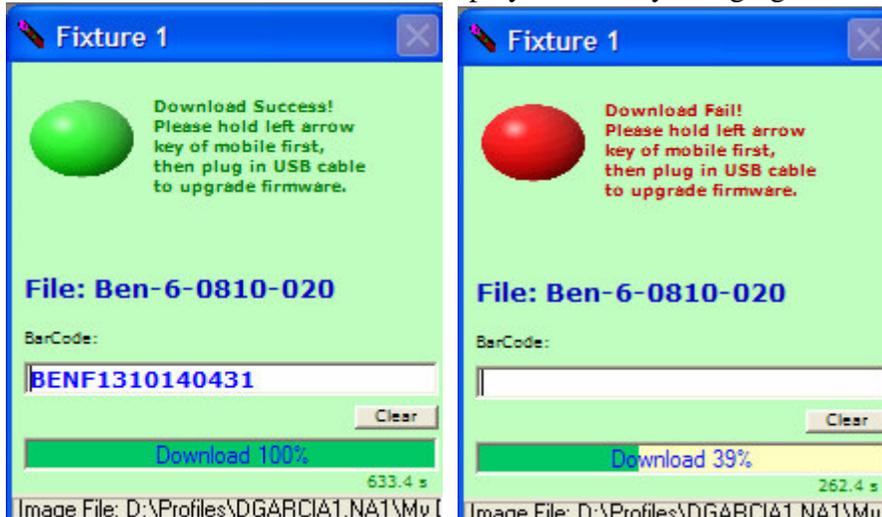
9. During the flash process the external LCD backlight will be blinking
10. Once the flash process is complete verify that each fixture's windows show "Download Success". Re-flash any unit that failed the upgrade. When the flash process is finished the external LCD will display the battery charging icon.

11. Verify completed flash by checking the appropriate fixture window and the external LCD behavior before removing the phone from the multi-flash station.
