FIELD SERVICE BULLETIN

FSB Number: LVCCFSB2004-154
Authors: Darwin Garcia
Date: July 22, 2004
Total No. of Pages: 2
Subject: **MPX200 Display Flex Connector Detached**
Model Affected: **MPX200**
Level of Repair: 1 & 2

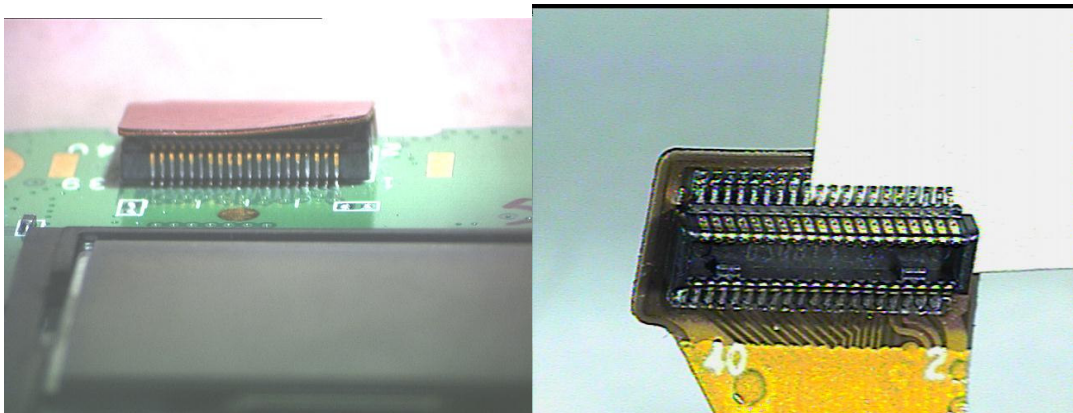
During the MOL analysis service detected a display flex problem in MPX200 GSM units; several samples were submitted to MFAL for analysis of failed solder joints on the FPC Upper to Lower BTB connector flex circuit, which connects the display board to the main board. The joints had failed during disassembly of the MPX200 at the repair center. The pictures clearly show bending at the corner of the flex circuit; this indicates disassembly by prying the flex assembly from the board at the corner. This is likely to concentrate stress at solder joints at the corresponding corner of the connector causing it to break. This issue can cause display and audio failures.

Flex Assemblies with Failed Solder Joints.

Repair centers must be directed to remove the connector with even force applied along the long edge of the connector to prevent concentration of the stress at the corner.

When disassembling any MPX200 display flex, apply even force along the edge of the connector. Units with the display flex connector detached must have the FPC Upper to Lower BTB Connector replaced.

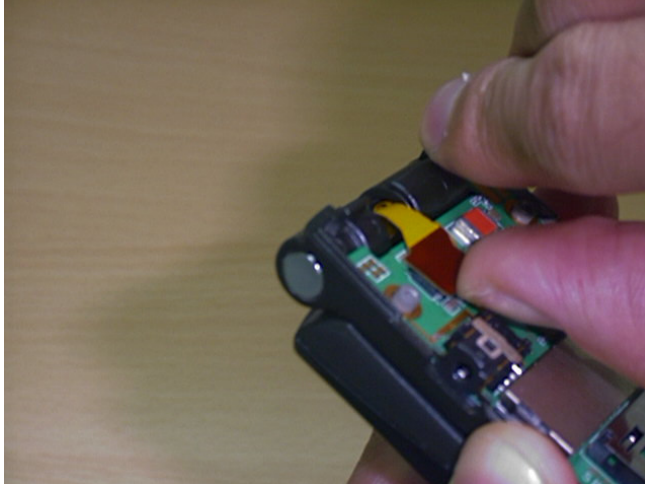
Proper removals of the FPC Upper to Lower BTB Connector.
