FIELD SERVICE BULLETIN

FSB Number: LVCCFSB2004-39
Authors: Darwin Garcia
Date: March 1, 2004 rwo-update June 10, 2004
Total No. of Pages: 2
Subject: **MPX200 Hang on HELLOMOTO Screen**
Model Affected: **MPX200**
Level of Repair: 2

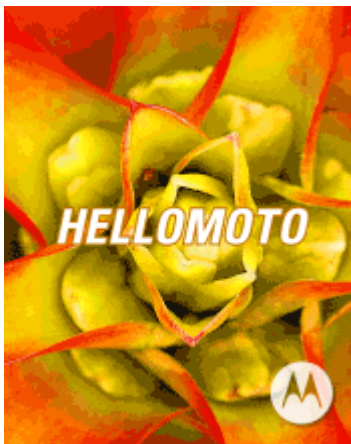
Picture 1 HELLOMOTO

During the NPI analysis, service detected a problem in all MPX200 GSM units with Smartphone 2002 and with IPSM 3.46 & 3.62. Affected phones will not turn on completely, it hang on the HELLOMOTO screen (Picture 1) or on the operator's screen (Pictures 2 & 3), so the battery need to be removed to turn off the phone. The cause of the problem is random memory corruption on the IPSM (Intel Persistent Storage Management) which is the flash file system with the user's data (Contacts, SMS/email, schedules). One possibility scenario for corruption is when IPSM is nearly full which generates a warning message (Picture 4), the user ignores it and continue receiving SMS or emails. Also the IPSM will try to search for more free space, a process called "Reclaim". Reclaim is very a computing-intensive process and if user turns off phone or even pull-out battery the IPSM does not completes the process and the IPSM could crash. The flaw in the operating system and the way is use that might cause random memory corruptions.

Customer phones that hang on the HELLOMOTO screen or on the operator's screen will need to re-flash with software the listed version which includes IPSM 3.7. AT&T model must be re-flashed with BEN-6-0810-020 and Orange model with BEN-6-0820-022. For EMEA markets uses BEN-6-0820-0XX or later and for ASIA markets uses BEN-6-0830-0XX or later. In Australia region please use Ben6-0890-048 .

When servicing any MPX200 customer's phones with described issue, it must be re-flashed with describe software version. Service recommends that all MPX200 in stock or repair be re-flashed with describe software version, contact your local service/account manager for re-flash plans.
