Field Service Information

MPX200 Incomplete Software Upgrade

Our Reference: SI32_5_2004

Product/System: MPX200

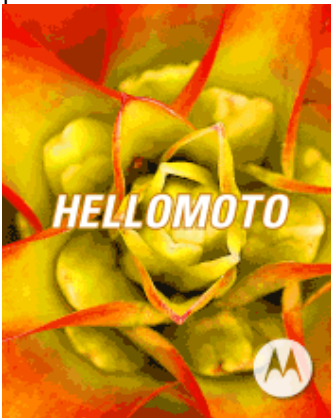
During an MPX200 reflash project, service detected a problem in MPX200 GSM units that were not completely flashed when using Upgrade Center 3.1. Affected phones will not turn on completely, depending on the percentage of the flash completed, most will hang on the HELLOMOTO screen, others might turn on but will not operate and in few cases not turning on. The battery will need to be removed to turn off the phone.

Customer phones that hang on the HELLOMOTO screen or does not operates will need to re-flash completely again. When utilizing Upgrade Center 3.1 with multi-flash stations operators should manually match the fixture's numbers with the port's label of the hub, label the USB cables accordingly, use fully charge batteries, and test all ports before major reflash projects.

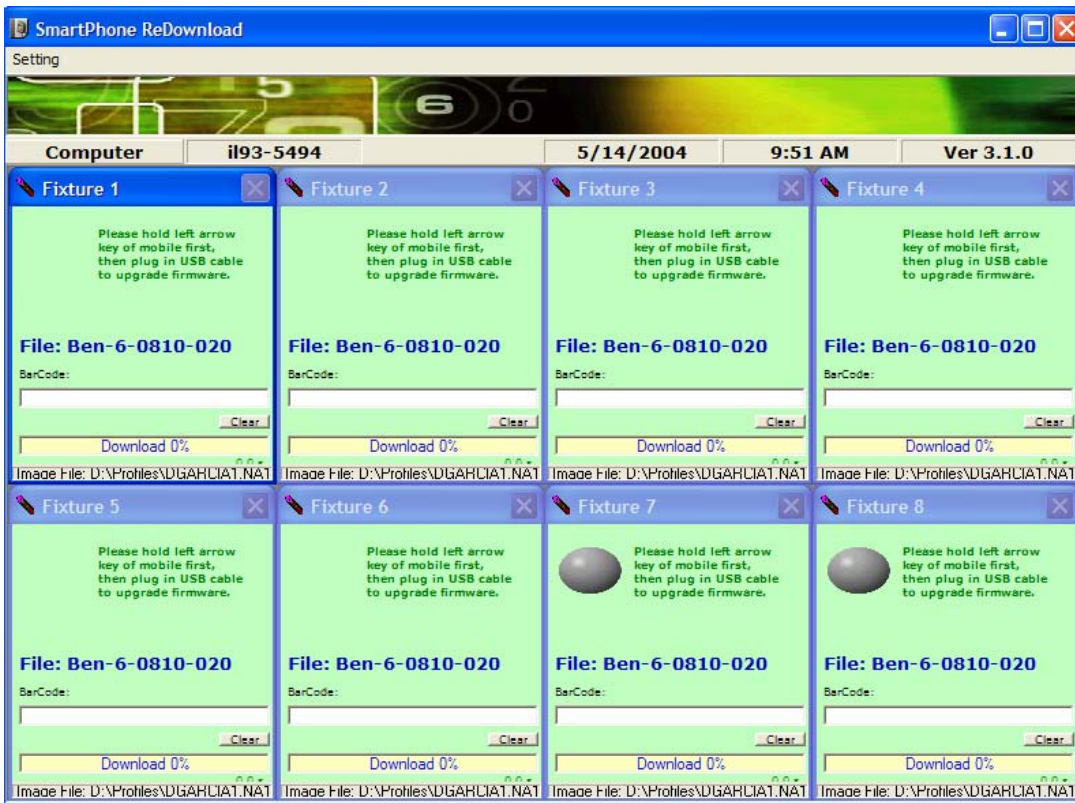
One of the causes of the problem is operator misunderstanding the fixture numbering sequence of the Upgrade Center 3.1 tool versus the physical number on the ports of the USB hub when utilizing a multi-flash station, which leads to inadvertently disconnecting the wrong phone before the software upgrade finishes. The numbers on the tool's fixture will not automatically match the physical label on the ports of the USB hub because the PC determines the internal COM port allocations base on ports activated and its capabilities. The upgrade center tool will select the order base of the PC systems port allocation, which makes keeping track of the ports alignment confusing during a major reflash project. Other possibilities are low battery, damage USB cables, USB hub ports freezing, PC system software/hardware failures, and Upgrade Center 3.1 software failures.

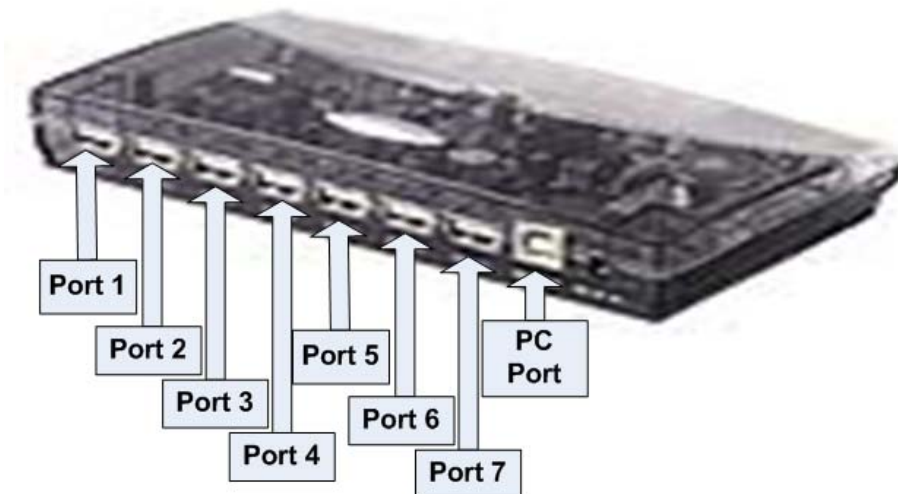
The fixture's numbers will not automatically match with physical port's labels of the hub.
