FIELD SERVICE BULLETIN

FSB Number: LVCCFSB2005-104
Authors: Darwin Garcia
Date: April 15, 2005
Total No. of Pages: 2
Subject: **MPX220 Black Housing Crack**
Model Affected: **MPX220**
Level of Repair: 2

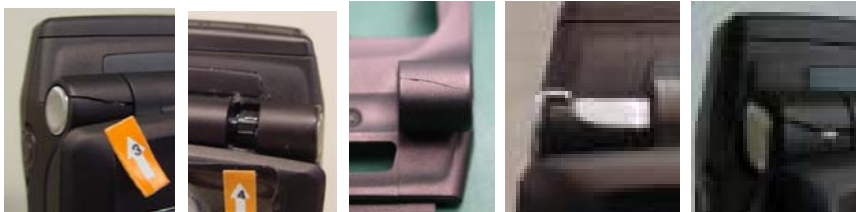
Service has detected a crack housing issue on the black model during MPX220 NPI process. Phones are being return for “Damaged Housing” complaints. The cracked housings were made in Dec of 2004 and ODM's analysis determined the root cause to be poor quality of the plastic raw material which was bought from Singapore GE agent.

Note: The injection date code of the case B+C is on the inner side of case C near the up key area and under the sponge. It will not easy to read since written by pen. The date code of the case B+C with new lot of plastic raw material from official agent should be 2005/03/26

When servicing any MPX220 customer phones with this failure replace the damaged housing(s). Part# MEMDS61012D Front Housing Black
