FIELD SERVICE BULLETIN

FSB Number: LVCCFSB2005-118
Authors: Darwin Garcia
Date: April 26, 2005
Total No. of Pages: 2
Subject: **MPX220 Incomplete SW Download**
Model Affected: **MPX220**
Level of Repair: 2

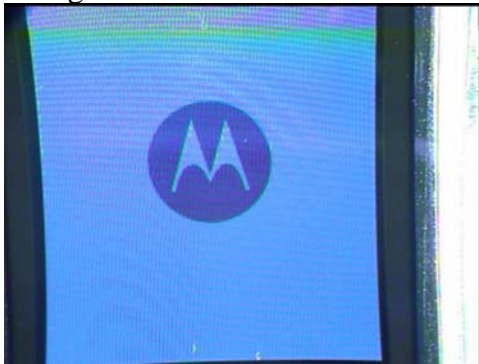
M-Logo Screen

Service has detected an incomplete SW download issue during MPX220 NPI process. Phones are being return for “Hang/Freeze” complaints. ODM's analysis determined that the software was not fully downloaded to the phone during reflash at the DC or field software upgrade. When the software is not fully downloaded the phone will hang on the M-logo screen when first turn on.

When servicing any MPX220 customer phones with this issue, the units must be reflash with latest approved SW and fully turn on the unit after download which could take 2-3 minutes.

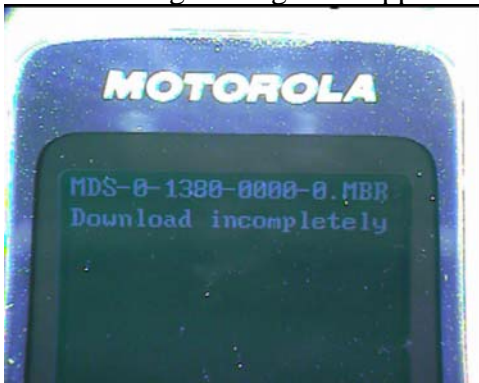
Warning Message

The new boot loader (OMP_Loader 3.270) and flash loader (2.170) in combination have a checking mechanism that if the device was not downloaded successfully, it won't boot and a warning message will appear on the screen.
