FIELD SERVICE BULLETIN

FSB Number: LVCCFSB2005-35
Authors: Darwin Garcia
Date: February 16, 2005
Total No. of Pages: 2
Subject: **MPX220 No Camera Image**
Model Affected: **MPX220**
Level of Repair: 2

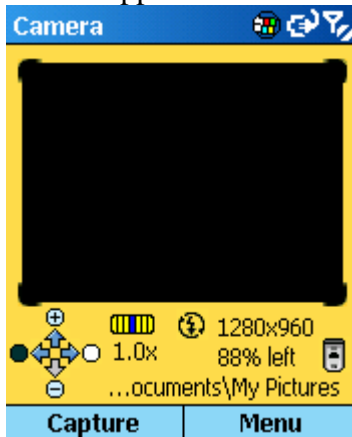
Service has detected a no camera image issue during MPX220 NPI process. When the camera application is enabled, a black image appears on preview pane.

When servicing any MPX220 customer phones with this issue, disassemble the rear flip housing, reconnect the camera flex to fixed position on the jig connector and ensure the connector's lock is in place. Re-test the camera functionally since a defective camera could cause the same symptom.

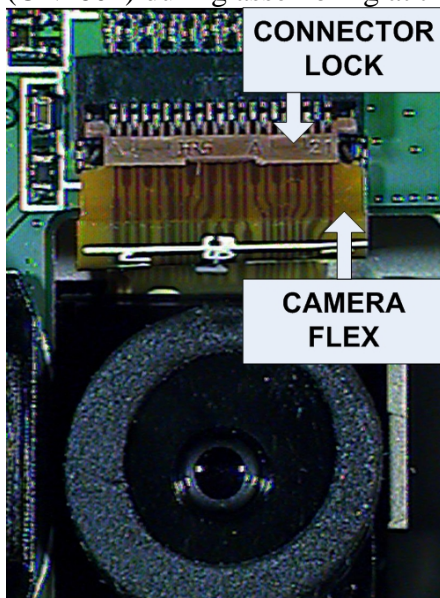
This is due to the flex of the camera not being pressed to fixed position on jig connector (CN1601) during assembling at the factory.

The factory modified the assembly process and enhanced testing to ensure the flex of the camera is pressed to fixed position on jig connector. Also the internal quality team will perform random audits.
