**FIELD SERVICE BULLETIN**

FSB Number: LVCCFSB2005-41  
Authors: Darwin Garcia  
Date: February 24, 2005  
Total No. of Pages: 3  
Subject: **MPX220 No Keypad Function**  
Model Affected: **MPX220**  
Level of Repair: 3

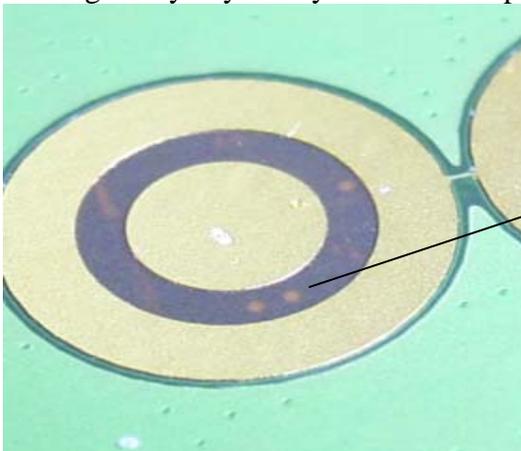
Service has detected a “No Keypad Function” issue during MPX220 NPI process. One or more button(s) on the main keypad will not work when pressed at any time. After further root cause analysis foreign material was found under the metal dome, which affected the connection when pressing key(s). The environmental control requirement at the supplier was not stipulated, due to this particles could adhere to the contact area causing heavy key or key not sensitive problem.

Particle inside the metal dome

The factory modified the assembly process by adding air gun cleaning station at the vendor, visual inspection before paste-on dome, and alcohol cleaning before metal dome assembly at the factory.

Perform standard mylar replacement procedure, which is to include cleaning the keyboard contacts and retest the failure.

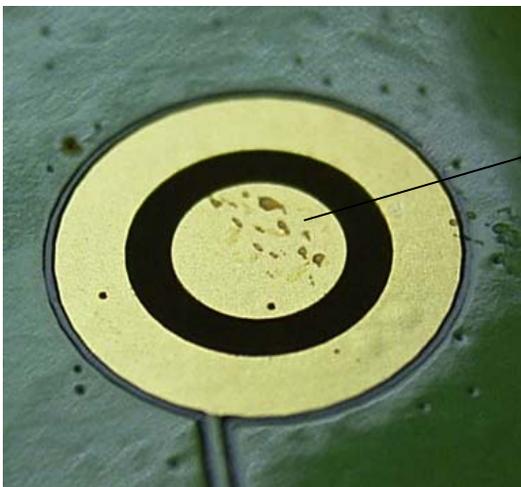
Particle inside the metal dome
