FIELD SERVICE BULLETIN

FSB Number: LVCCFSB2005-61
 Authors: Darwin Garcia
 Date: March 11, 2005
 Total No. of Pages: 2
 Subject: **MPX220 SIM Connector Pins Buckling**
 Model Affected: **MPX220**
 Level of Repair: 3

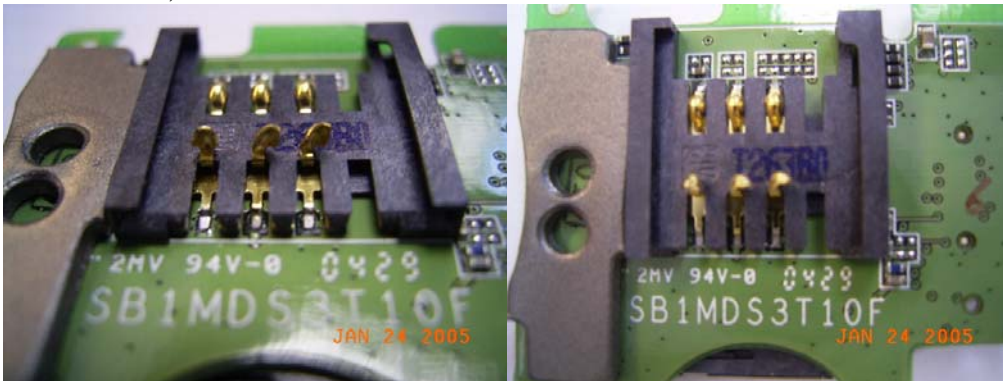
Service has detected a SIM connector issue during MPX220 NPI process. Phones are being return for damage SIM connector pins occurring when inserting the SIM card for the first time, most evident in the Asia market.

When servicing any MPX220 customer phones with this issue, repair the daughter board (31MDS00030F) by replacing the damage SIM connector (SN0CC411060). Perform SIM testing with a thicker (0.84 mm) dummy SIM card to adjust the pins' position.

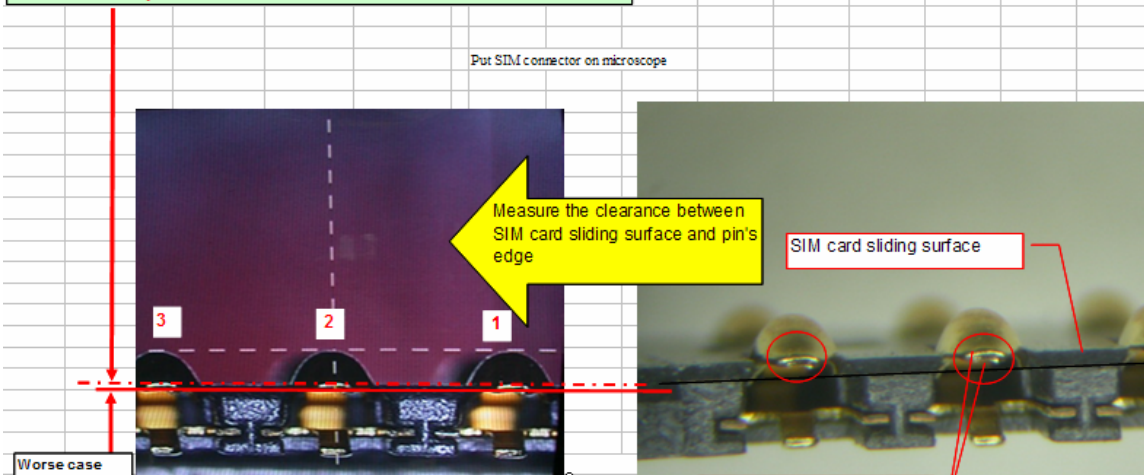
The clearance between the SIM card sliding surface and pin's edge is too high in some connector, however failing part were within the original specs.

The clearance could be 0.049 mm in some cases and such small clearance may cause SIM card to impact on the pin's upper edge and bend the pins.

Hamburg (SIM card connector supplier) modified the tool to move the pins edge lower, from original design distance 0.05+0.08 mm to 0.1+0.08 mm. It was expected to reduce the potential risk of pins buckling. Hamburg replaced all the piece parts in CMCS factory with the new SIM connectors for new built on February 5 2005. Also, new built units will have a mark dot on case D lower left corner.
