# Field Service Information

**MPX220 SIM Connector Pins Buckling**

Our Reference: SI17-3-2005

Our Reference: SI17-3-2005 Product/System: MPX220

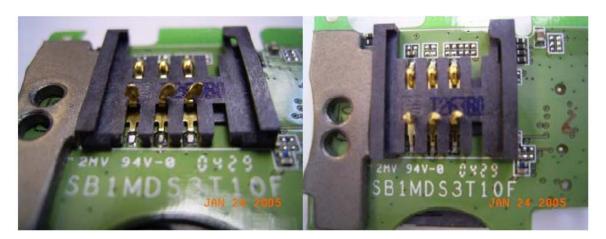
Service has detected a SIM connector issue during MPX220 NPI process. Phones are being return for damage SIM connector pins occurring when inserting the SIM card for the first time, most evident in the Asia market.

The clearance between the SIM card sliding surface and pin's edge is too high in some Connectors, however failing part were within the original specs.

Hamburg (SIM card connector supplier) modified the tool to move the pins edge lower, from original design distance 0.05+0.08 mm to 0.1+0.08 mm. It was expected to reduce the potential risk of pins buckling.

When servicing any MPX220 customer phones with this issue, repair the daughter board (31MDS00030F) by replacing the damage SIM connector (SN0CC411060). Perform SIM testing with a thicker (0.84 mm) dummy SIM card to adjust the pins' position.
