FIELD SERVICE BULLETIN

FSB Number: BJCCFSB2006-184
Author: Jianfeng Ma
Date: April 28, 2006
Total No. Of Pages: 3
Subject: **GSM PEBL U6 No Earpiece - solder open**
Model Affected: GSM PEBL U6
Level of Repair: 2

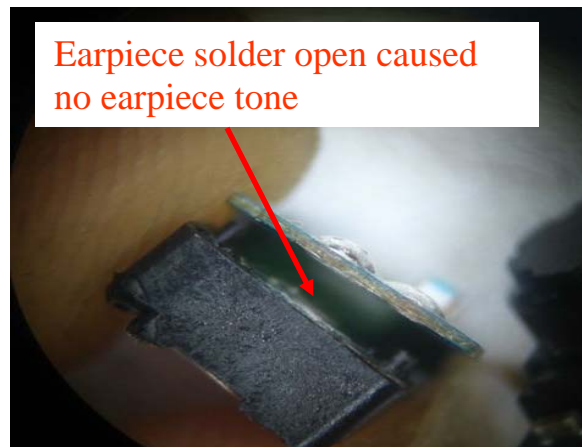
Service is aware of an issue identified during the U6 MOL Analysis. Some units, returned with a customer complaint of "Audio ,Earpiece , No", were found no earpiece audio as a result of earpiece solder open on the Camera Flex Assy. The root cause was determined to be wrong setting on soldering temperature.

Supplier Flextronics has implemented corrective actions:

- A) To implement additional in-process 100% physical inspection on the speaker soldering open failures at soldering station and OQA station. (Date implemented: 7 Mar 2006)
- B) To implement additional inspection on the soldering temperature from once per day to once every 2 hours. (Date implement: 7 Mar 2006)

- a. Swap the flip with a known good flip. If earpiece failure follows the flip, then
- b. Disassemble the flip and check the Camera Flex Assy connector if fully seated with the display board. (If not seated well, then press the connector to make sure a good connection and test again.)
- c. Replace the Camera Flex Assy with a known good part. If failure follows the Camera Flex Assy, then replace a new part with date code 1106 or later. (PN: 8489235Y01)
- d. If the unit displays the original failure symptoms with the known good part, then proceed with normal troubleshooting techniques as per the customer complaint.

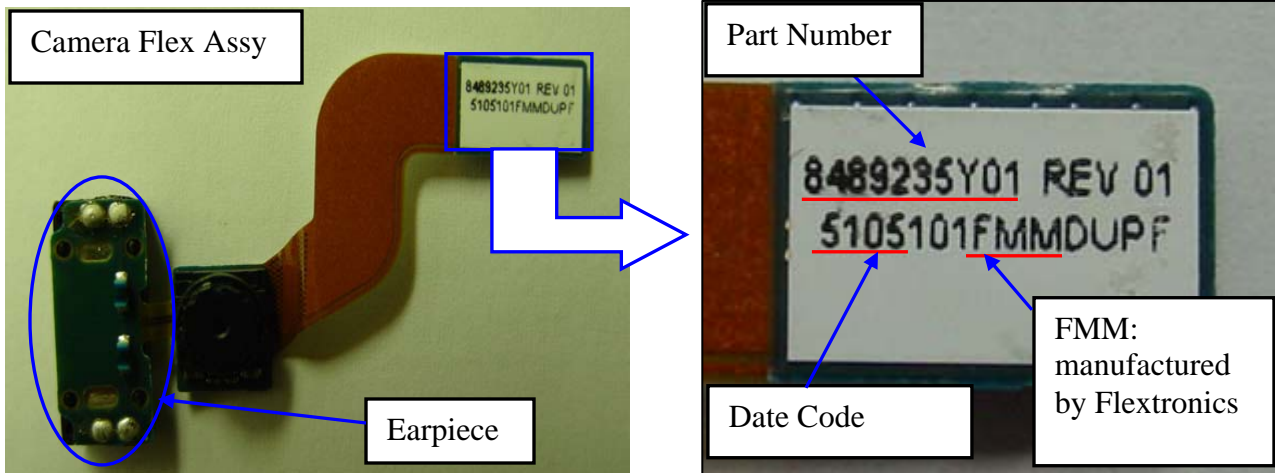
Flextronics date code identification:

The improved Camera Flex Assy with Date code 1106 or later. (Week 11, 2006)

Ensure the new parts with date code 1106 or later are ordered for service.
