FIELD SERVICE BULLETIN

FSB Number: LVCCFSB2005-365
Author: Tony Bryan
Date: January 03, 2006
Total No. of Pages: 3
Subject: GSM PEBL U6 – Battery Contact Alignment
Phone Models: GSM PEBL U6 – SJUG10xxAA and SJUG16xxAA
Level of Repair: 2

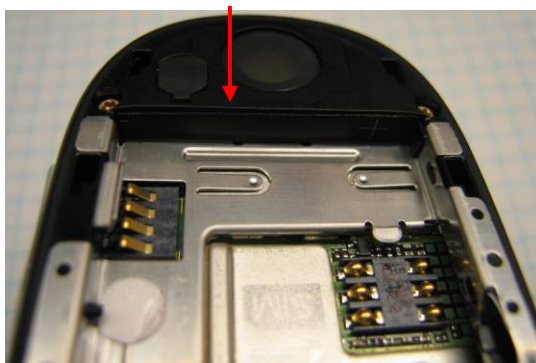
Service is aware of a pre-launch issue on GSM PEBL U6 phones that could potentially cause customers to return units with complaints related to No Turn On. The root cause of the issue is that the width of the PCB battery contacts closely matches the width of the contacts on the battery. When installing the battery, there is a potential for improper battery to battery contact alignment. When this occurs the PCB contacts may rest on the battery pack insulator ribs, preventing power and causing the customer to experience a No Turn On failure.

Short-Term: Prior to product launch, a thin strip of lexan material was added to the battery cavity as a shim to help ensure proper battery to battery contact alignment. See Image Below.
