FIELD SERVICE BULLETIN

FSB Number: LVCCFSB2006-121
Author: Tony Bryan
Date: April 24, 2006
Total No. of Pages: 3
Subject: GSM PEBL U6 – Rear Housing Screw Torque
Phone Models: GSM PEBL U6
Level of Repair: 2

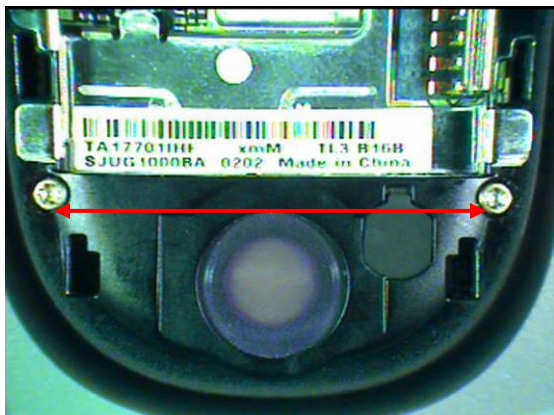
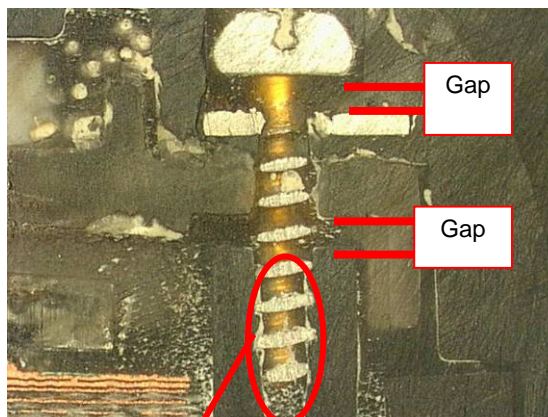
The issue occurred on the bottom two self-tapping R-Hsg Screws. The screw bosses were closely examined, confirming the screws were never driven in completely at factory assembly. After the screws were re-tightened to the proper settings, the failures could no longer be duplicated. See Images below.

Less than 4 threads engaged with F-Hsg boss.

The Factory Quality Team has investigated this issue and confirmed failure can occur in production on some torque drivers with torque measuring on the low end of spec. Original Torque Specification was 1.25 in-lbs (+/- 10%). In addition, the factory found that the speed setting of the driver (high speed is about 700 rpm and low speed is about 500 rpm) can affect the torque and result in a higher rate of occurrence.

1. Calibration of all torque drivers to high end of torque spec (1.30 in-lbs.)
2. Mandatory setting of all torque drivers to High Speed (700 RPM)
3. 2 x Re-Torque of screws at the above settings to ensure fully driven
4. 100% Inspection for 'loose screw' during assembly and at FQA Audits

A new torque study was completed by Factory and ME Team which has resulted in an increase in the Torque Specification for the R-Hsg Screws.

New Torque Specification Target: 1.33 in-lbs.

(Upper Tolerance 1.37 in-lbs. / Lower Tolerance 1.30 in-lbs.)

1. Ensure all four R-Hsg Screws are tightened to the proper torque by attempting to re-tighten with a calibrated torque driver. Using New Torque Specification noted above.
 - a. If the R-Hsg Screws are not found to be noticeably loose when attempting to tighten, then proceed with normal troubleshooting techniques to identify the problem, per the customer complaint.
