**FIELD SERVICE BULLETIN**

FSB Number: LVCCFSB2006-287  
Author: Tony Bryan  
Date: July 07, 2006  
Total No. of Pages: 3  
Subject: GSM PEBL U6 – Intermittent Alert Audio (Pogo-Pin)  
Phone Models: GSM PEBL U6  
Level of Repair: 3

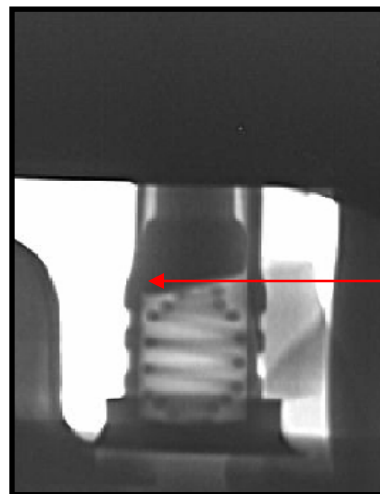
X-Ray image of U6 Pogo-Pin (3988194N07)

Service is aware of an issue identified in the NPI Analysis of the GSM PEBL U6 product. Some units, returned with customer complaints of “Alert– No Ringtone” and other related alert audio complaints, were found to be caused by poor mechanical connection internal to the alert pogo-pin connector (3988194N07). This failure mode is extremely intermittent and can be recovered and induced by flexing or shocking the rear housing in the area of the alert speaker. The root cause has been determined to be insufficient Nickel (Ni) and Gold (Au) plating on the pogo terminal inner surface and a low contact force between pin and pogo terminal inner surface.

Mechanical Connection Point

- (1) 100% inspection of terminal plating and connector resistance implemented at supplier site on March 20th.
- (2) A re-design of the 3988194N07 pogo-pin was completed to increase contact angle from 15 degrees to 20 degrees. The increase in contact angle will provide a higher side contact force internal to the pogo-pin.

#### **New Pogo-Pin Part Number: 3988194N14**
