FIELD SERVICE BULLETIN

FSB Number: LVCCFSB2006-84
Author: Tony Bryan
Date: March 20, 2006
Total No. of Pages: 3
Subject: GSM PEBL U6 – Low/Distorted Microphone Audio
Phone Models: GSM PEBL U6
Level of Repair: 2

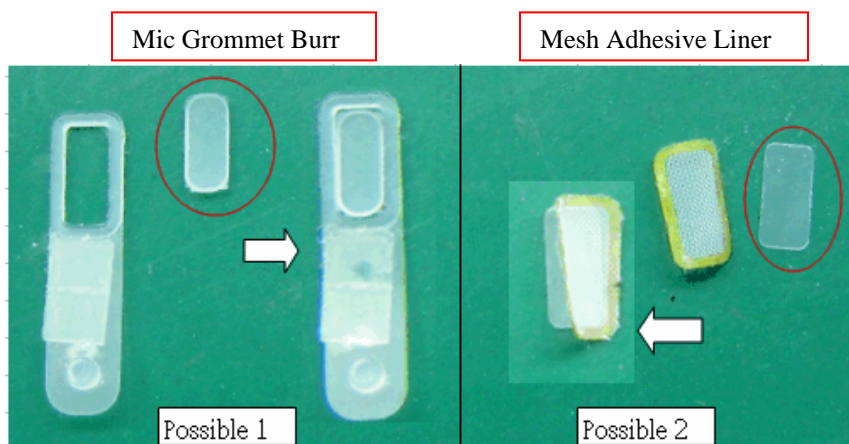
Service is aware of an issue on some GSM PEBL U6 phones, identified during the NPI Analysis, which affects Microphone Audio. Some units, returned with customer complaints related to “Low/Distorted Microphone Audio”, were found to have a problem with the Microphone Grommet (0588611Y02) placed underneath the keypad. Analysis revealed that plastic material was blocking the acoustic opening of the grommet preventing audio to the microphone. Factory Quality Team identified two root causes for this type of failure.

Root Cause #1 - No hole in grommet caused by grommet supplier not properly cleaning up burr from grommet.

Root Cause #2 - The clear acoustic mesh adhesive liner was not removed by operator at factory assembly when assembled into housing.

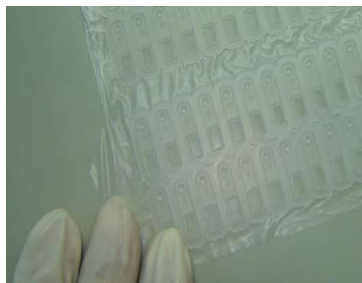
Before Improvement

1a. Grommet Supplier “MingShun” modified their inspection process for grommet hole to implement a black background instead of by using white background, which can easy for detect the bad one. 2/7/2006 Please refer to the pictures below.

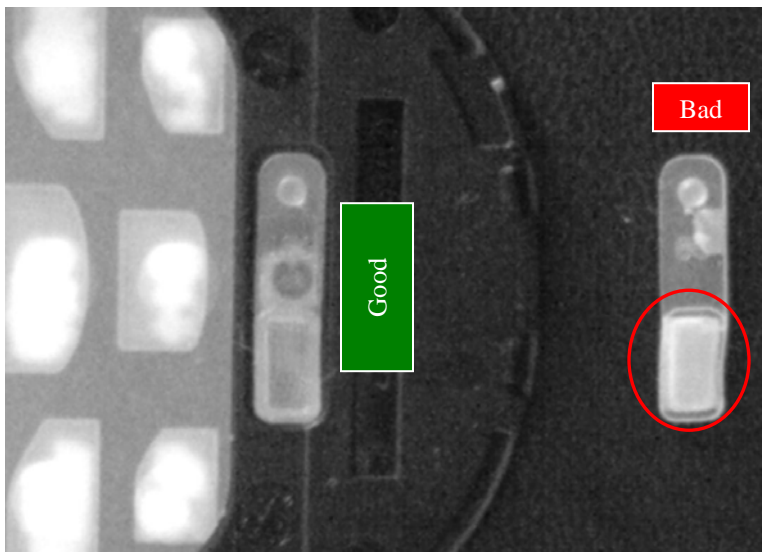
1. Disassemble the front housing, remove the keypad, and inspect the Microphone Grommet for this issue. See Image Below.
 - a. If the unit is determined not to have this issue, then follow normal troubleshooting procedures to determine the problem.
2. Replace the Microphone Grommet (0588611Y02).
3. Reassemble the unit and retest to ensure proper repair.
